Restoration Case study Seminar series 1.0

Part One Rooftop plaza restoration

This case Study describes how certain design details combined with environmental factors caused the premature failure of a roof top parking slab in Denver Colorado.

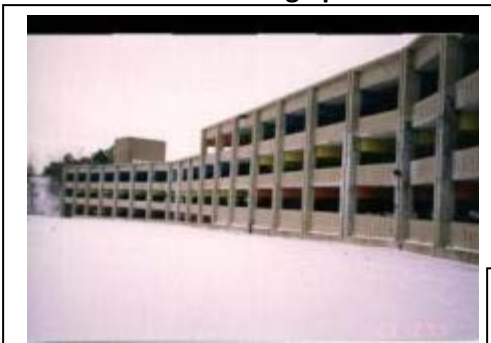
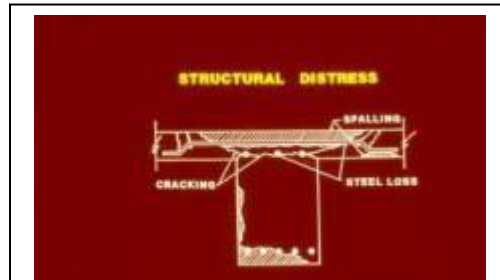
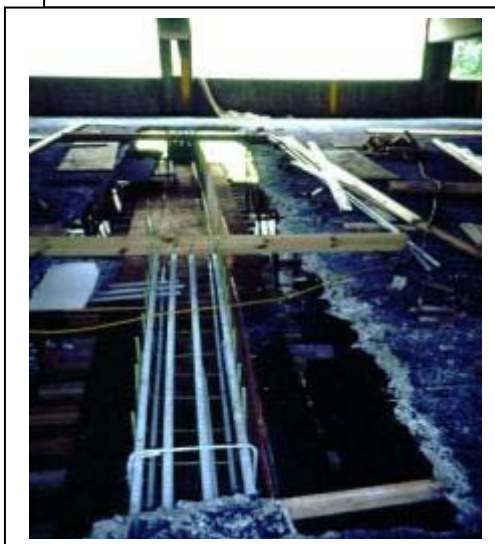
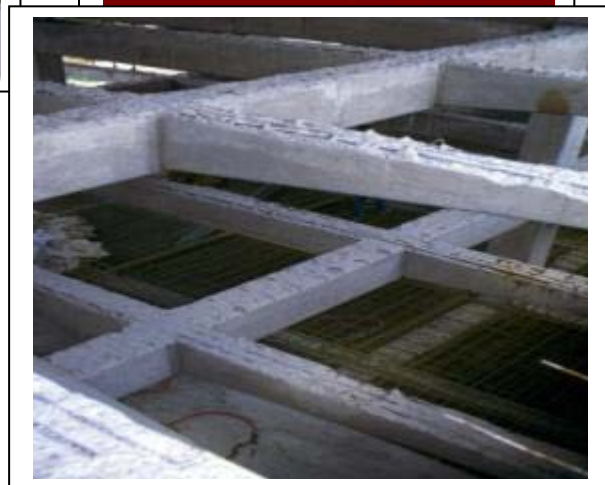
- Existing 30 year old "Parking" slab has corrosion (of embedded reinforcing bars) damage on over 40% of the surface and 25% of the ceiling – Making it essentially unsalvageable

- Isolated "haunched" main beams were showing shear type failure and certain (spandrel) or strut beams were cracked at their junction with the mains.
- Expansion joint beams (and columns) were showing irregular cracking patterns and judged to need stiffening.

- 25 year service life restoration plan was requested by owner with low maintenance expectations.
- Full slab removal and replacement on the lower 3 floors was recommended. Bonded High Performance Overlay was called out for the roof

- Construction was sequenced to;
 - Replace the slab out to (and under) the parapet wall
 - Thicken all expansion joint beams and support columns
 - Repair damaged interior "Main" beams first before slab work

- Do an Outer ring demo and putback first and then continue with an inner ring sequence 2nd
 - Replace the closed in Stairtower masonry with glass curtain walls

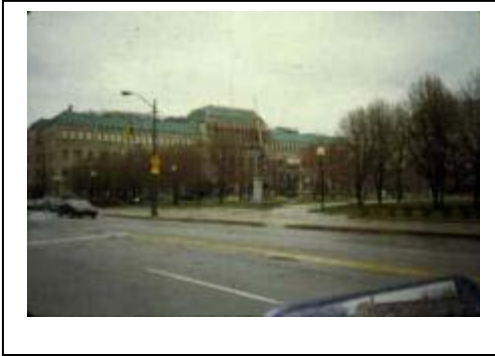
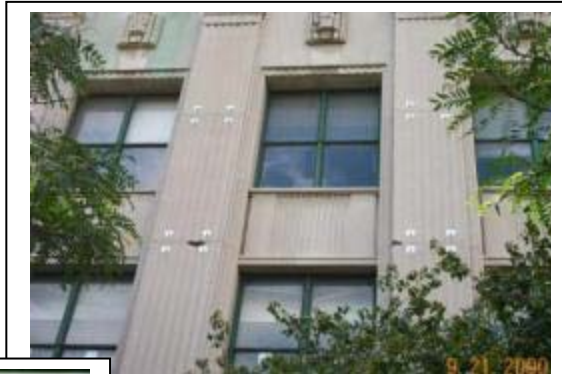
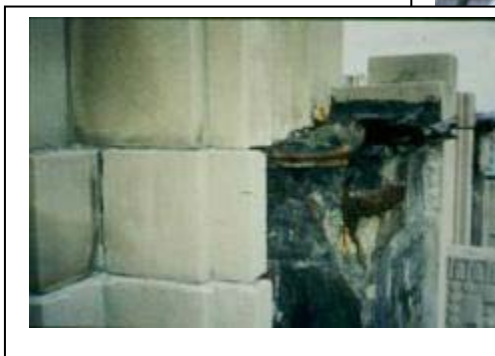
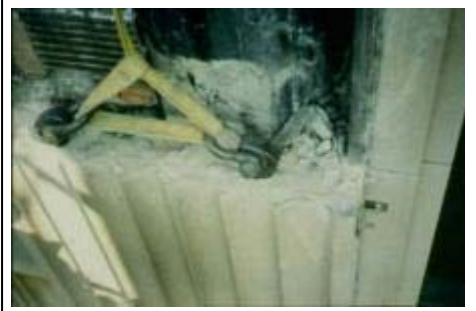
Case study # 5 – Historic Building Exterior Façade Restoration – 1930’s – This structure is clad in ornate limestone panels with major connector and shelf support angle problems. Corrosion damage on many of the angles caused failure of the limestone connectors by spalling of both surface (and backside) limestone sections resulting in indeterminate behavior. Damage panels were dismantled catalogued/inventoried and repaired, primarily by Dutchman methods (partial section removal and replacement). Project Date; 1991---Budget \$750 - \$850,000

New anchors were installed in the Virgin panel sections remote from the original failure. Following dismount connector angles/assemblies were removed and replaced with galvanized steel and new connector pins were fabricated for inlaying and concluding repairs to the remaining panels in place.

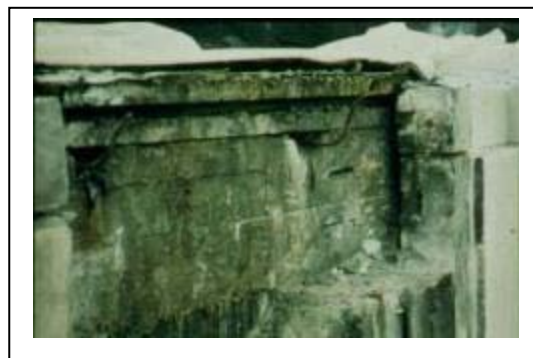
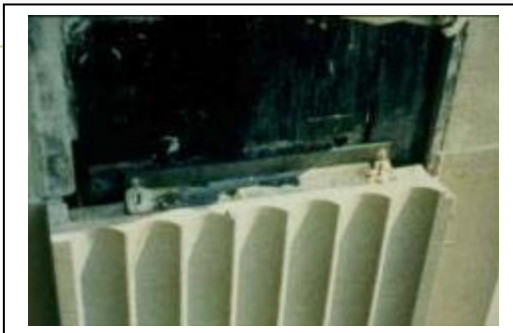
- Panel spalling – Face & Backside
- Tieback overstressing/pullout
- Shelf angle corrosion/displacement
- Stone to stone Connector pin failure
- Backup material failure
- Steel frame Corrosion

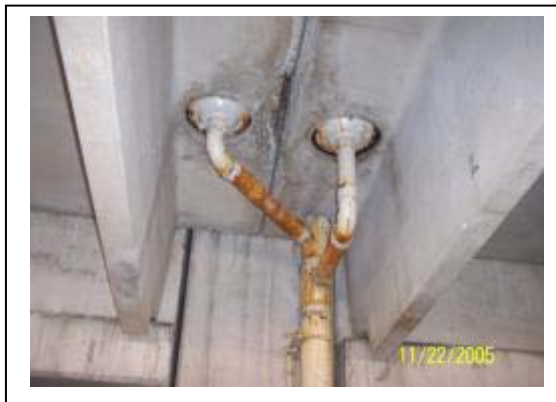
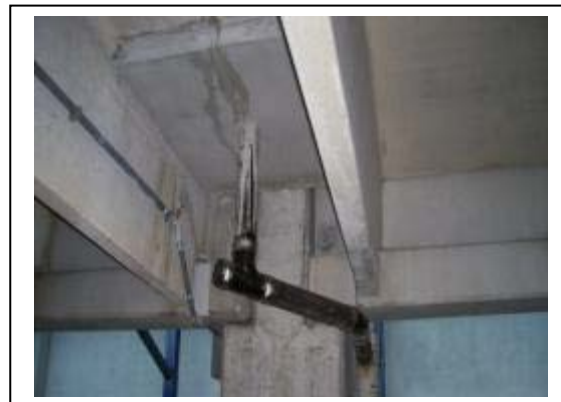
- 1) **Drain basin restoration** -Drain basins on the rooftop, originally constructed to accommodate the pre-casters production system had leaked sense the earliest days of facility operation. Leaking caused rapid/ progressive corrosion of the connectors, pipes, fittings and constant staining the vehicles below. Double drains installed as part of original construction were replaced with larger single drains encased in substantial concrete block-outs to avoid leaking and movement. The new drain eliminates piping and provides for easier maintenance with the appropriate clean outs.

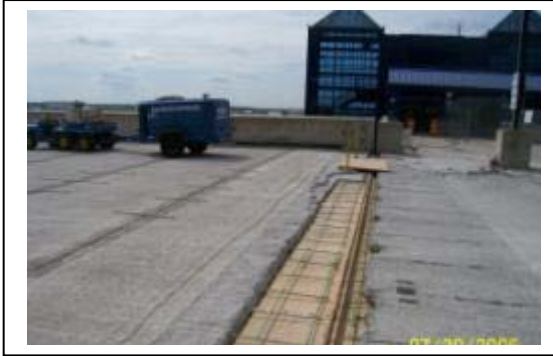
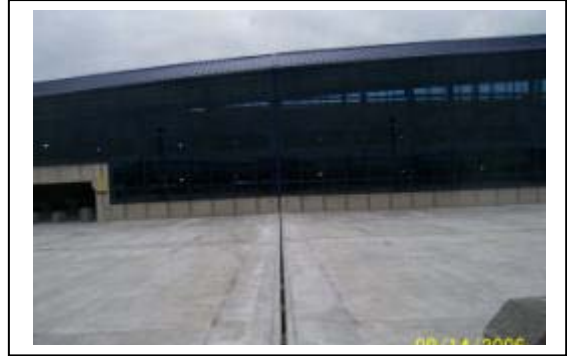
- 2) **Expansion joints repairs** - Expansion joints were cast into conventional concrete nosing with little if any taper and slope to reduce leakage. Metal retainer assemblies had experienced snowplow damage and The leaking through these joints was also a problem soon after construction and continued until Carl Walker's restoration 2006. Nosings were reconfigured and rebuilt using latex modified concrete consistent with the overlay material. Watson Bowman strip seals were installed on the new tapered nosing. Joint openings were reduced slightly to accommodate the actual structural movement.

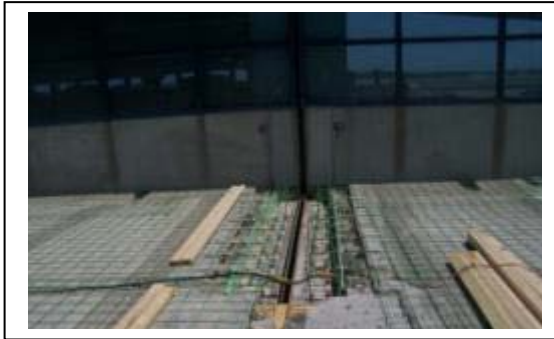
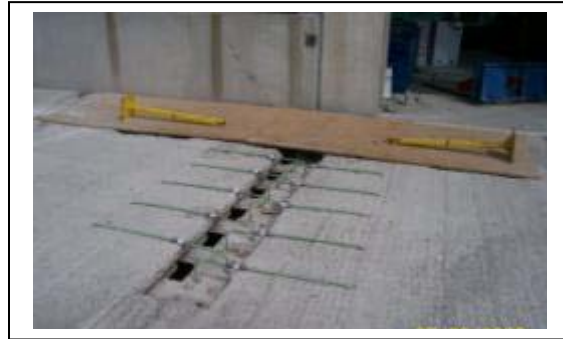
- 3) **Shear wall refitting** - The shear walls along the central corridor portion of the deck had marginally bonded concrete caps and were structurally disconnected, or only marginally connected to the frame. Wall tops (the connection zone) were reconfigured and structurally reinforced to provide positive connection between the shear wall and the double tee floor system.

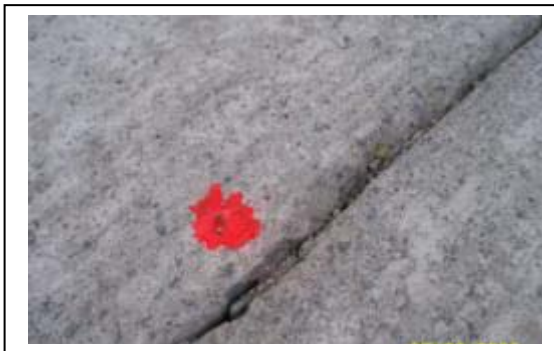
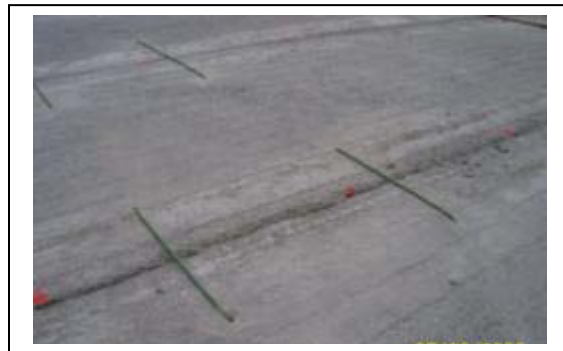
- 4) **Flange connector repair** - Flange connectors (double T. to double T.) experience major damage because of the original design/construction tolerances, difficulty with field welding, corrosion during service from sealant failure and severe loading during winter snow removal. This combination of conditions produced widespread failure and complete disconnection of numerous T. flanges. Complete redesign of the tee flange reinforcing was performed and integrated into the overlay to correct all of the above conditions with a 3 step process; mesh reinforcing, stitch rod installation, re-welding failed original connectors, including aggregate interlock and joint width reductions. This process corrected the previous condition of joint leaking associated with the failed connectors, with this multi task process.

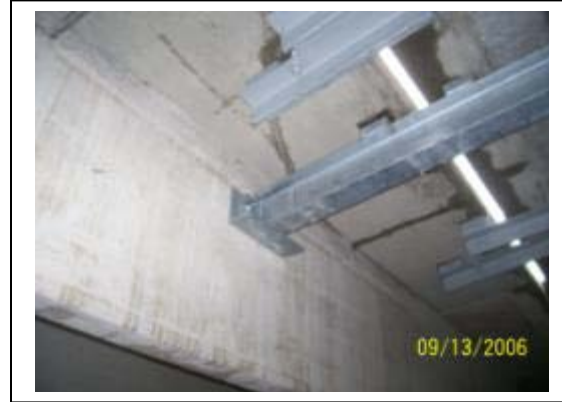
- 5) **Transfer beam installation** - Many of the expansion joints show differential movement from tee to tee during vehicle transit. Previous assemblies, angles installed in pairs, had worked loose during service and, experience loosening or failure. This combined with joint leaking above and corrosion problems had produced an unacceptable assembly and system. Existing connectors were reconditioned to provide proper contact. Additionally, transfer beams were used in the main driveline for severe loading of winter maintenance operations.

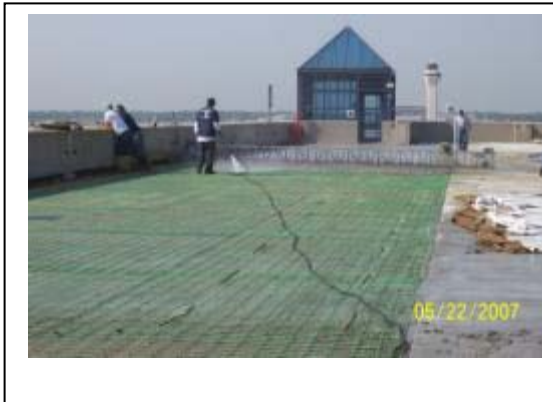
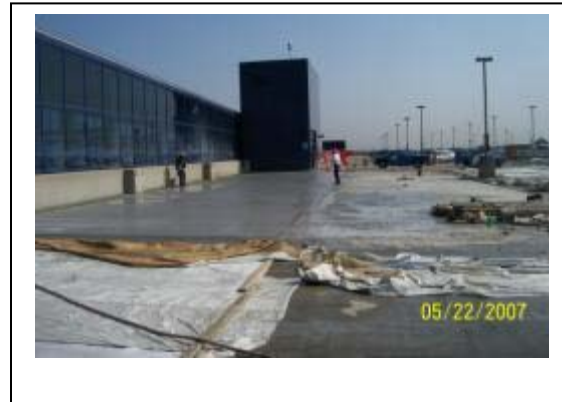
- 6) **Overlay placement - drainage grade improvements** The existing deck surface consisted of lightweight aggregate double Tees of the Pretopped variety. Although designed the grade lines provided satisfactory macro drainage, many of the T's were installed with variations in the upper flange surface. This produced micro ponds on many of the T's in the drain line region and caused considerable difficulty during snowplowing when the equipment damaged elevated tee edges.

- 7) **To correct these numerous conditions**, the existing deck surface was milled down 1 in. for a new 1-1/2in. thick overlay of latex modified concrete. The new surface provides improved long-term durability over the lightweight Aggregate concrete, improves drainage gradients to reduce micro ponding, accommodated providing smaller joints, and eliminates differentials, improving the overall ride and reducing future distress from snowplowing operations.
