Western Clay Manufacturing Company Conservation Praxis 2012 Field Report

Archie Bray Foundation
Montana Preservation Alliance

The Architectural Conservation Laboratory
School of Design
University of Pennsylvania
December 2012

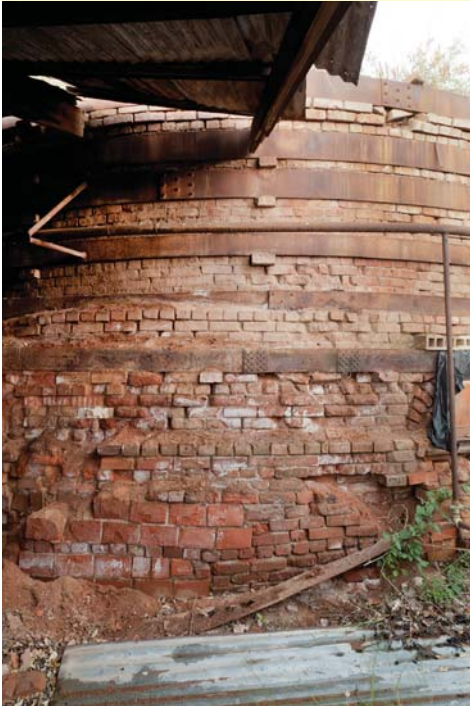
Pilot Section 1

Before Treatment July 2011

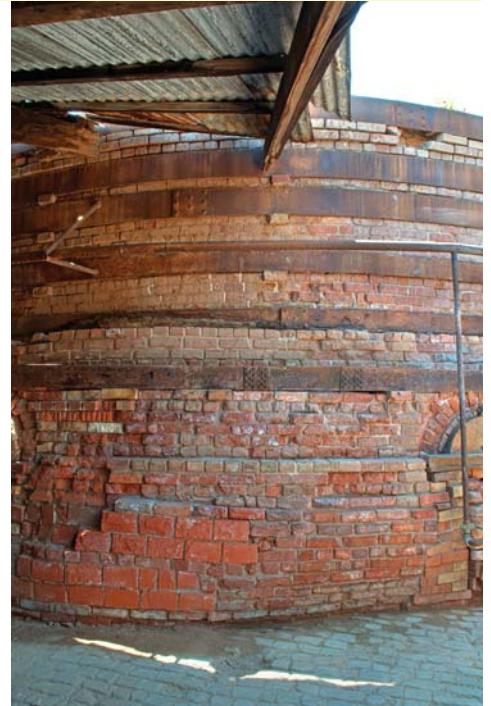
After Treatment July 2012

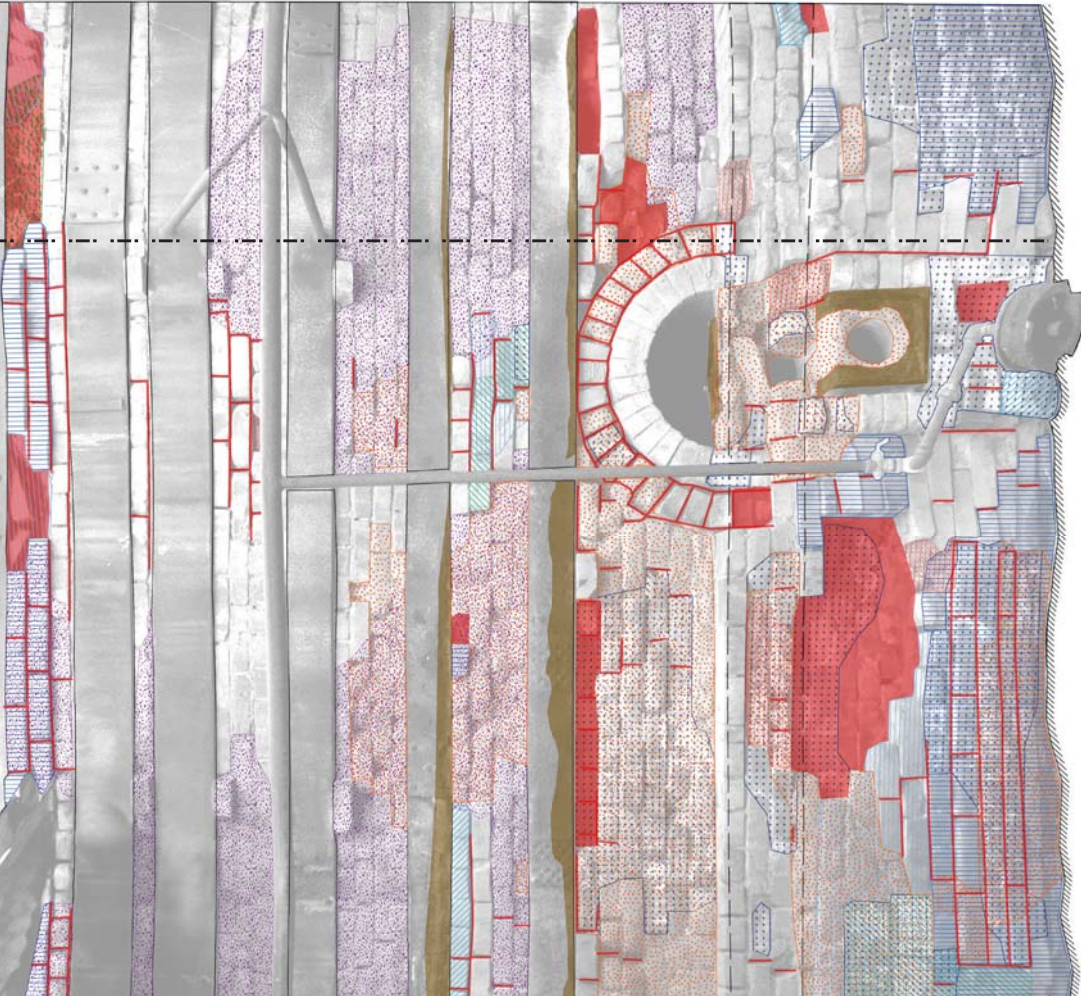
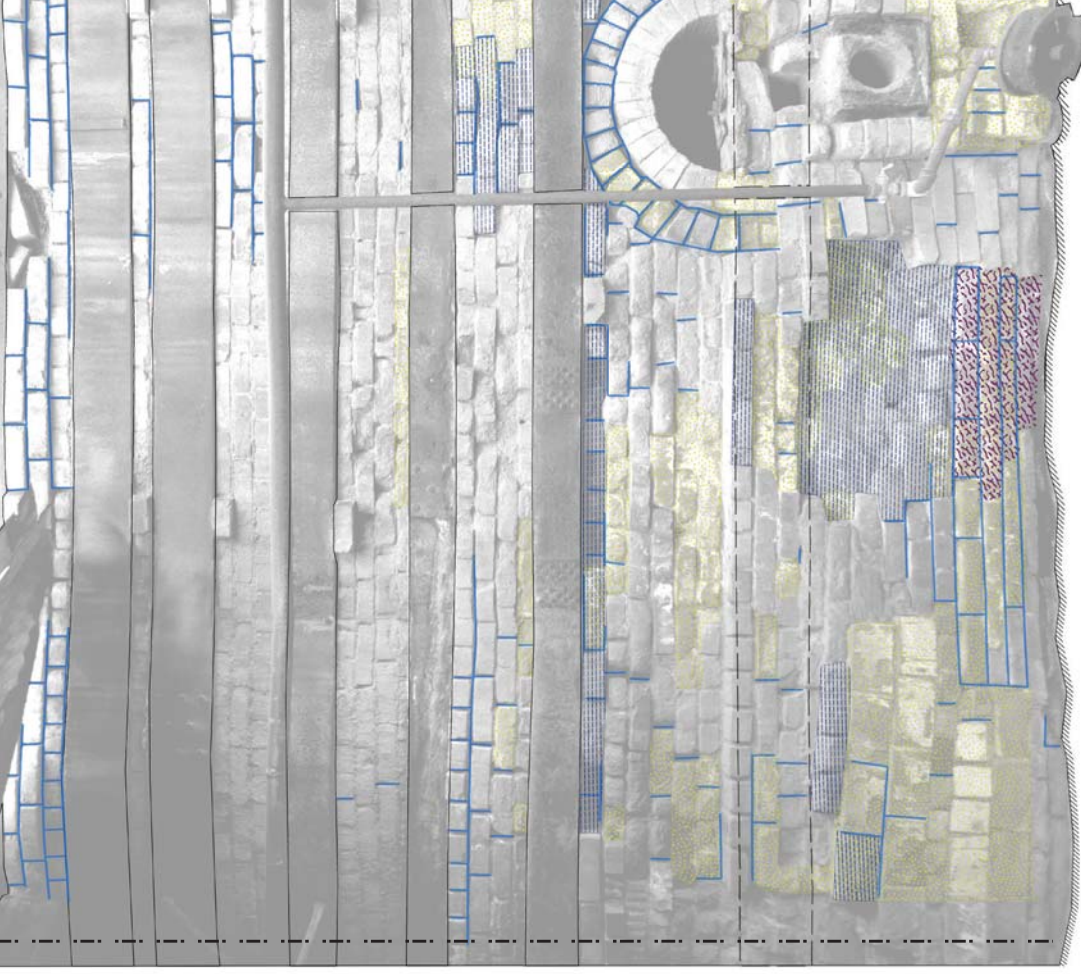
- Out-of-Plane Displacement
- Rotation
- In-Plane Displacement
- Repair

- Section Limits
- Band Missing
- Corrosion

Treatments

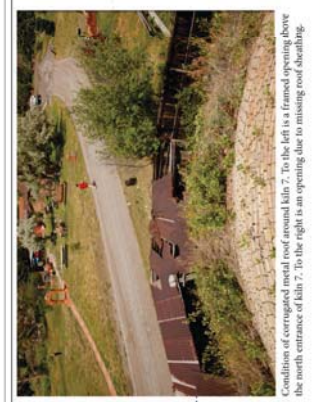
Conditions of corrugated metal roof of Kiln 7. To the left is a framed opening above the north entrance of Kiln 7. To the right is an opening due to missing roof sheathing.

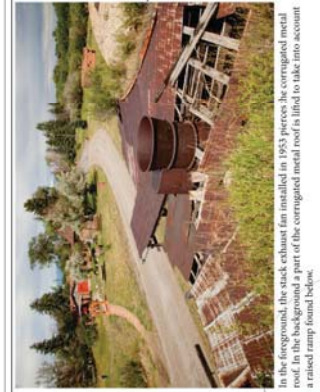
In the foreground, the stack exhaust fan installed in 1953 pierces the corrugated metal roof. In the background a part of the corrugated metal roof is lifted to take into account a raised ramp found below.

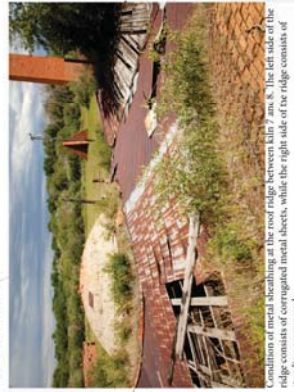
Accumulation of metal sheathing at the roof ridge between Kiln 6 and 8. The left side of the ridge consists of corrugated metal sheets, while the right side of the ridge consists of standing seam panels.

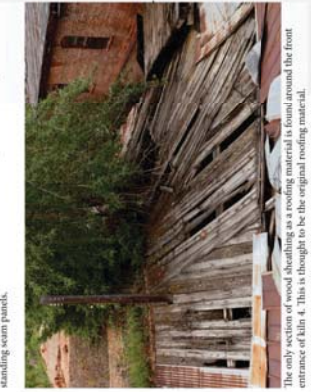
The only section of wood sheathing as a roofing material is found around the front entrance of kiln 4. This is thought to be the original roofing material.

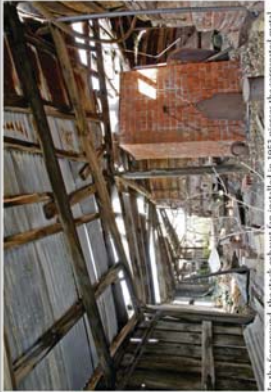
In the foreground, the stack exhaust fan installed in 1955 pierces the corrugated metal roof. Part of the corrugated metal roof is lifted to take account a raised ramp found below.

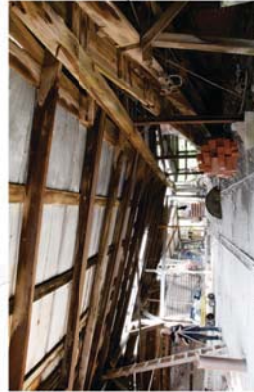
Condition of metal sheathing at the roof ridge between kiln #7 and #8. The left side of the ridge consists of corrugated metal sheets, while the right side of the ridge consists of standing seam panels.
