THE NEWLIN GRIST MILL TAILRACE EXISTING CONDITIONS ASSESSMENT

209 SOUTH CHEYNEY ROAD
GLEN MILLS, PA 19342

J&M PRESERVATION
STUDIO

COVER SHEET

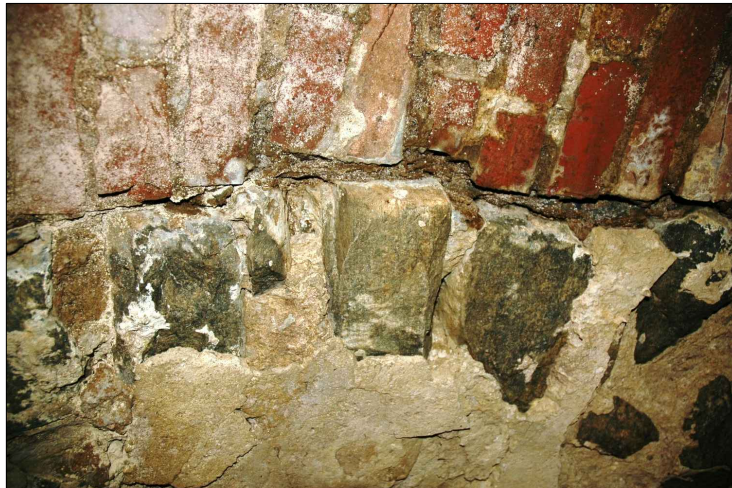
#19 STA 71'-5": TRANSITION BETWEEN BRICK & STONE IS NOT KEYED INTO EACH OTHER

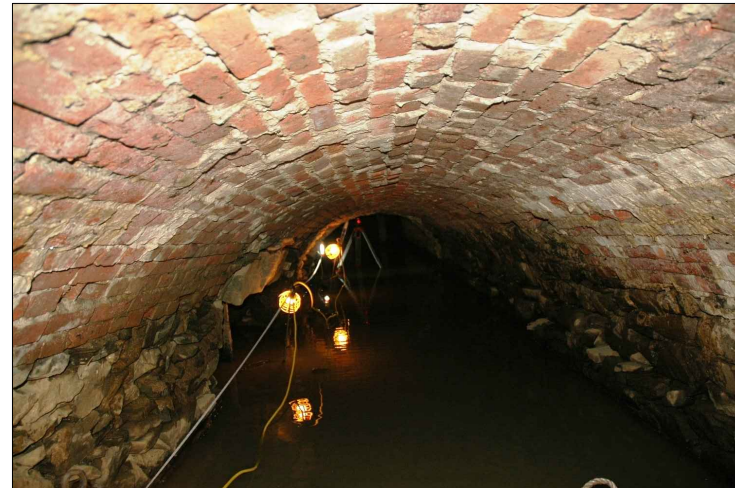
#139 STA 30 (LOOKING WEST): BRICK VAULT IS IN VERY GOOD CONDITION

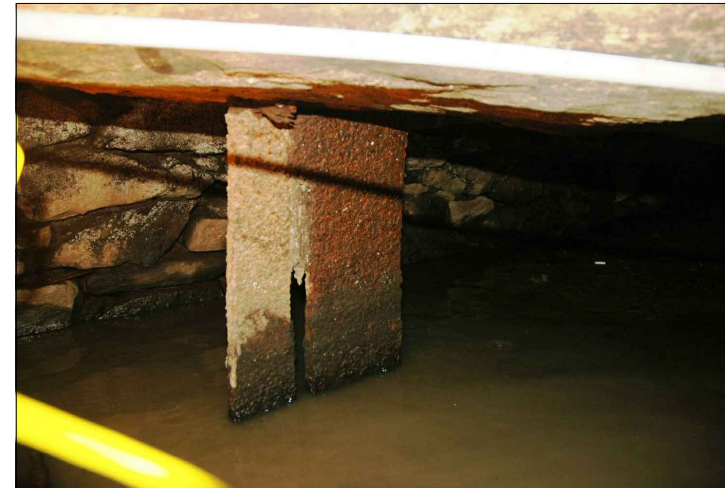
#129 STA 16 SOUTH (ENTRANCE TO SAWMILL TAILRACE): STEEL SUPPORT PLATE IS SEVERELY CORRODED

PROCEDURE FOR STONE LINTEL SUPPORT DETAIL, STA 13'-5"-19'-5":
 1. DRAIN STANDING WATER AND REMOVE SILT FROM BASE OF TAILRACE.
 2. VACUUM DEBRIS ALONG BASE, JUST BELOW LINTEL, FOR CLEAN SURFACE. NOTIFY ENGINEER OF ANY NEW CONDITIONS ONCE BASE IS VISIBLE.
 3. INSERT STONE MASONRY ALONG JAMBS AS INDICATED IN DETAIL 4/S1. (OPTION A: UTILIZE SCHIST MASONRY STONES. OPTION B: UTILIZE CMU).
 4. REMOVE CORRODED STEEL PLATE AT MIDLINE AFTER STONE MASONRY HAS SET.

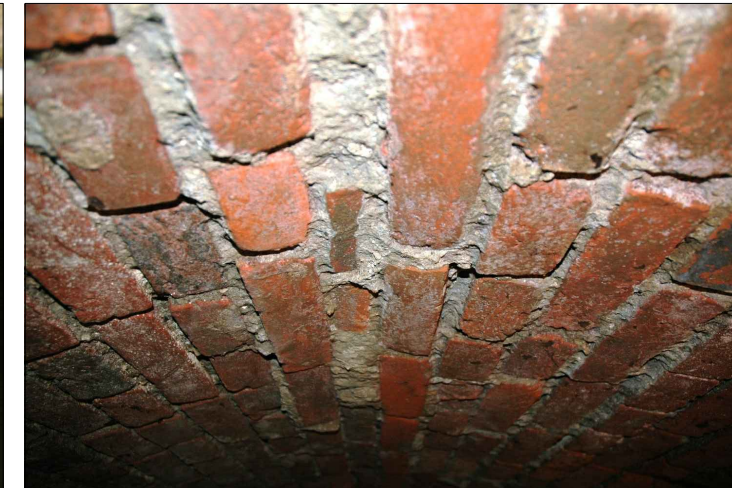
#125 STA 10: OVERHEAD BRICKS ARE IN GOOD CONDITION

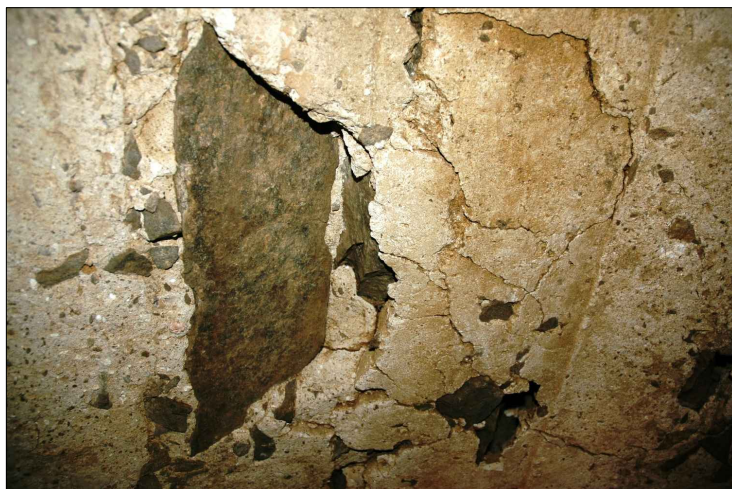
#24 STA 60: OVERHEAD PARGING IS CRACKED

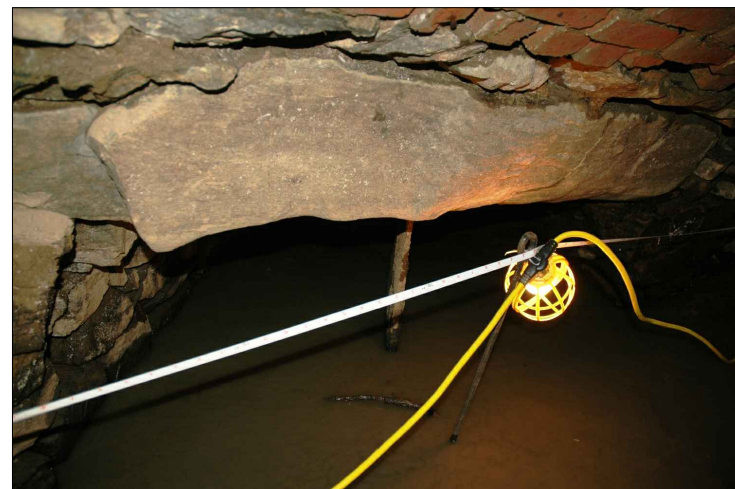
#133 STA 19'-5" SOUTH": EAST END OF STONE LINTEL IS UNSUPPORTED

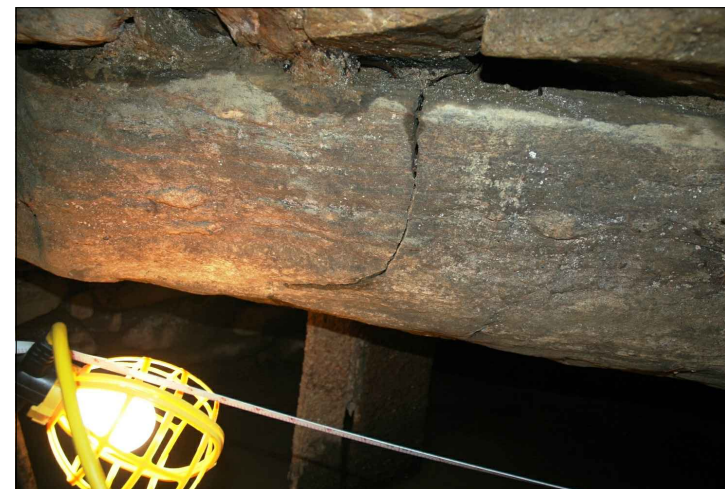
#126 STA 16 SOUTH (ENTRANCE TO SAWMILL TAILRACE): VERTICAL CRACK AT MIDPOINT OF STONE LINTEL

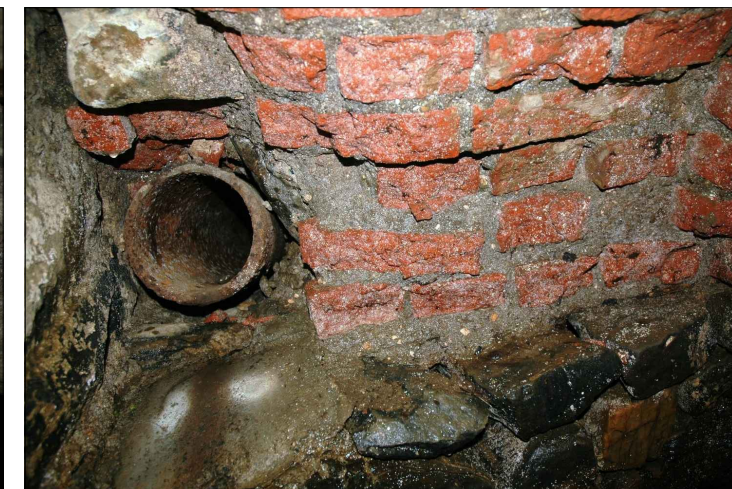
#121 STA 5'-5" NORTH ELEVATION: TERRA COTTA DOWNSPOUT

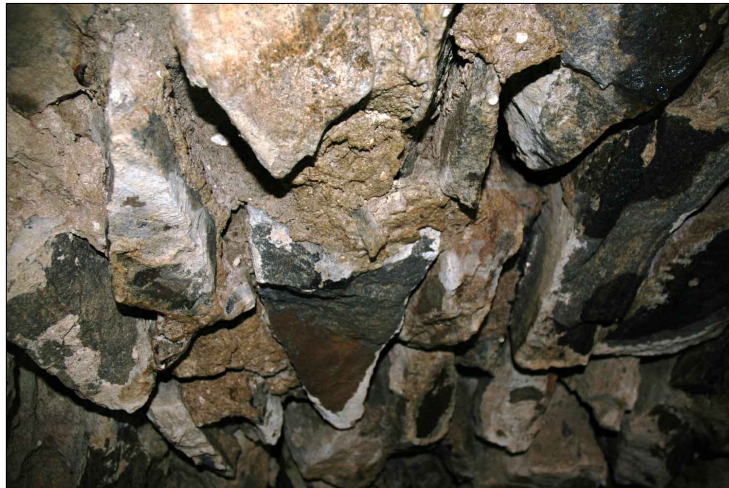
#71 STA 150: OVERHEAD STONE IS DRY LAID

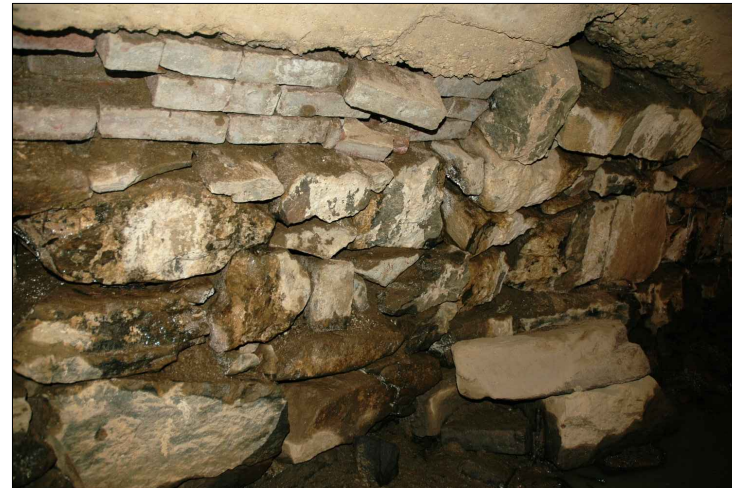
#59 STA 130 NORTH: LOOSE STONES, BRICKS FALLING OUT FROM WALL

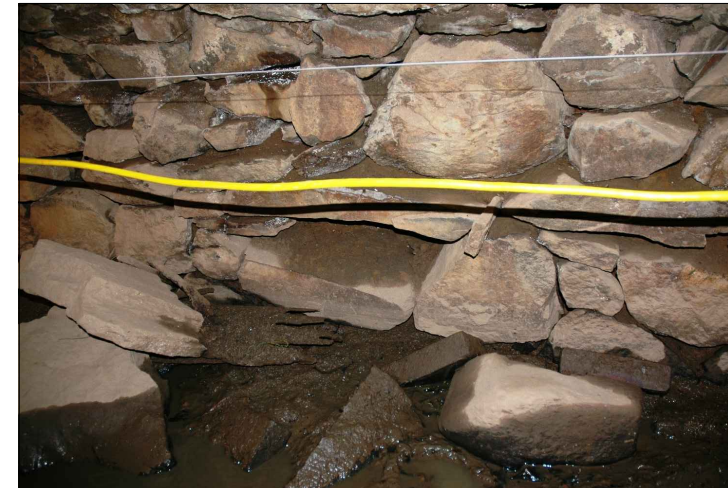
#47 STA 112 SOUTH: MANY STONES FELL OUT AT BASE OF WALL

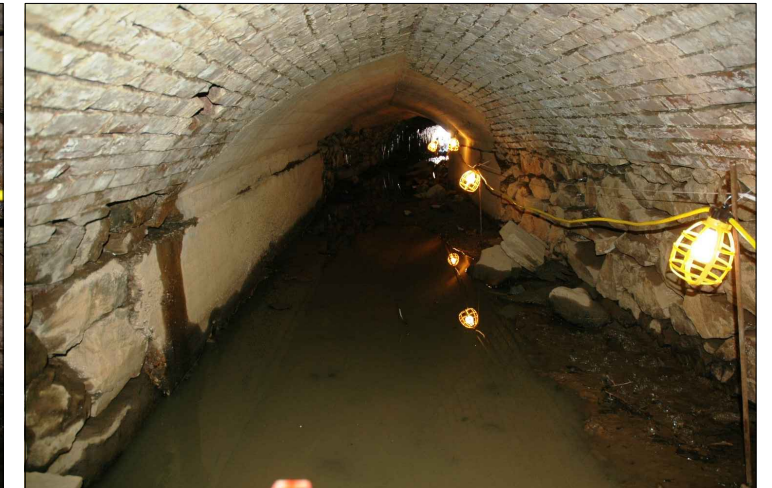
#06 STA 102 (LOOKING EAST): BRICK ARCH IS VAULTED & COMES TO A POINT

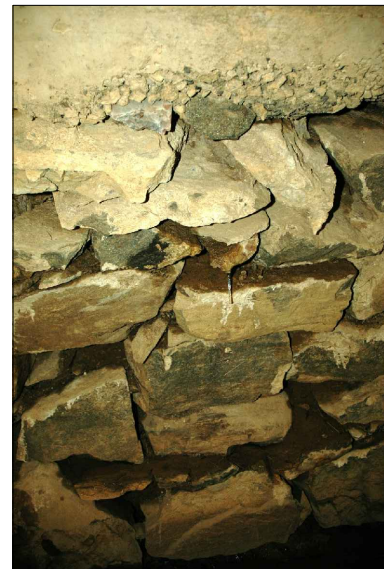
#62 STA 140 NORTH: LOOSE STONE

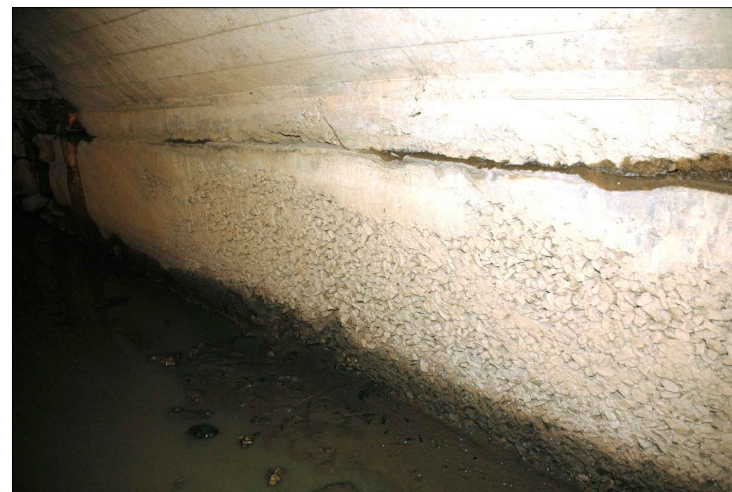
#52 STA 120 NORTH: QUALITY OF CONCRETE AT WATER TABLE IS POOR

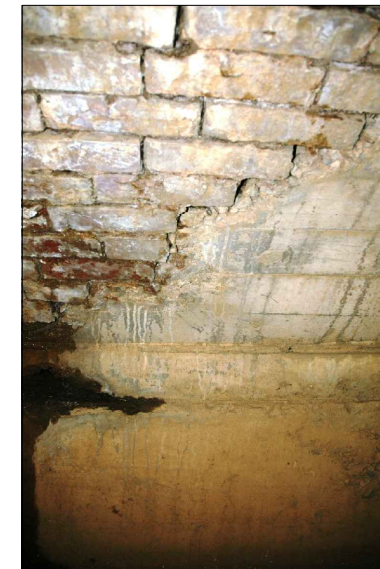
#45 STA 110 NORTH: CONCRETE AT BASE ALONG WATER TABLE COVERS STONE FOUNDATION

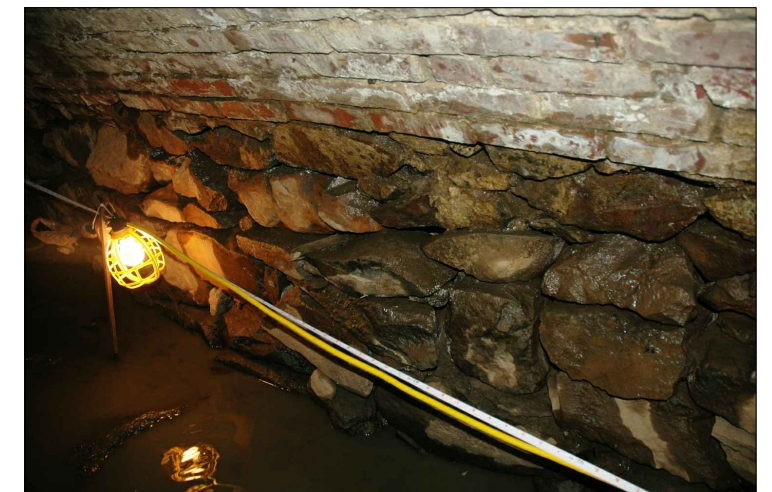
#11 STA 94 SOUTH: STONES ARE BULGED

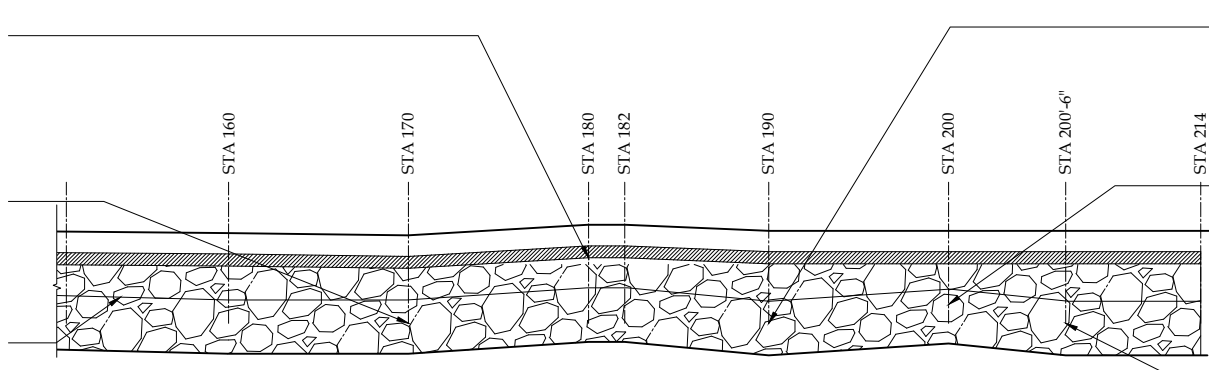
3 STA 151-214: NORTH ELEVATION WALL - CONDITIONS
SCALE: 3/32"=1'-0"

STA 180: TWO VOIDS OVERHEAD. MAJOR EFFLORESCENCE. VERY LARGE STONES, 36"-38" LENGTH.

STA 170: MAJOR EFFLORESCENCE. VERY LARGE STONES, 36"-38" LENGTH.

STA 153: MAJOR STONE COLLAPSE, 24" WIDE STONE FELL.

STA 190: SMALLER STONES AT BASE, LARGE BOULDERS AT MIDPOINT, LOOSELY LAID. ICICLES OVERHEAD.

STA 200: SMALLER STONES AT BASE, NOTCHED STONE INDICATES THAT THIS PARTICULAR STONE WAS SALVAGED FROM ANOTHER SOURCE/BUILDING.

STA 200-214 LICHEN ON WALLS. SMALLER STONES AT BASE, LOOSELY LAID, MORE STABLE THAN STA 160-180.

STA 180: RESET STONE WITH BEDDING MORTAR.

STA 153: RESET STONE WITH BEDDING MORTAR.

STA 190: RESET STONE WITH BEDDING MORTAR.

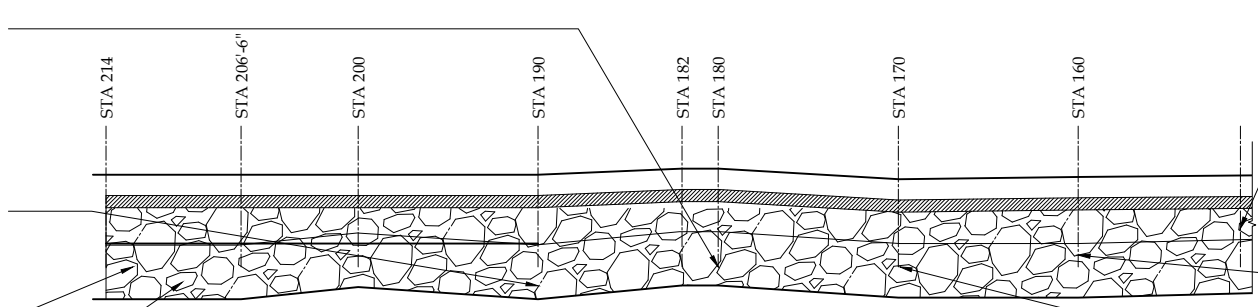
1 STA 151-214: SOUTH ELEVATION WALL - CONDITIONS
SCALE: 3/32"=1'-0"

STA 180: STONE LOSS AT BASE OF FOUNDATION ~14". STONES ARE LARGE IN THE AREA, LOOSE & DRY PACKED.

STA 190: VERY LARGE STONES AT BASE. LARGE VOIDS FROM WHERE THE SMALLER STONES HAVE FALLEN OUT ALREADY.

STA 200-214: LICHEN ON WALLS.

STA 190-214: VERY LARGE BOULDERS AT BASE OF WALL.

STA 151: STONE COLLAPSE ~16".

STA 160-162: STONE COLLAPSE ~30".

STA 170: STONES COMING OUT, LOOSE & HANGING.

STA 180: RESET STONE WITH BEDDING MORTAR.

STA 190: RESET STONE WITH BEDDING MORTAR.

STA 151: RESET STONE WITH BEDDING MORTAR.

STA 160-162: RESET STONE WITH BEDDING MORTAR.

STA 170: RESET STONE WITH BEDDING MORTAR.

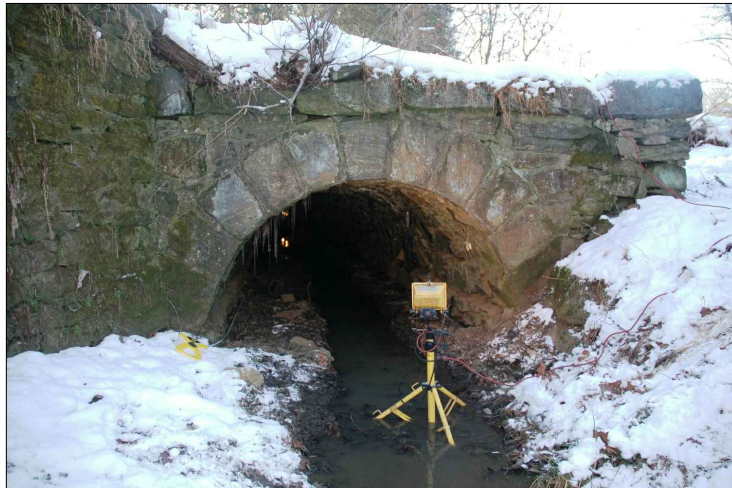
#103 STA 214: HEAD WALL, EAST SIDE OF TAILRACE

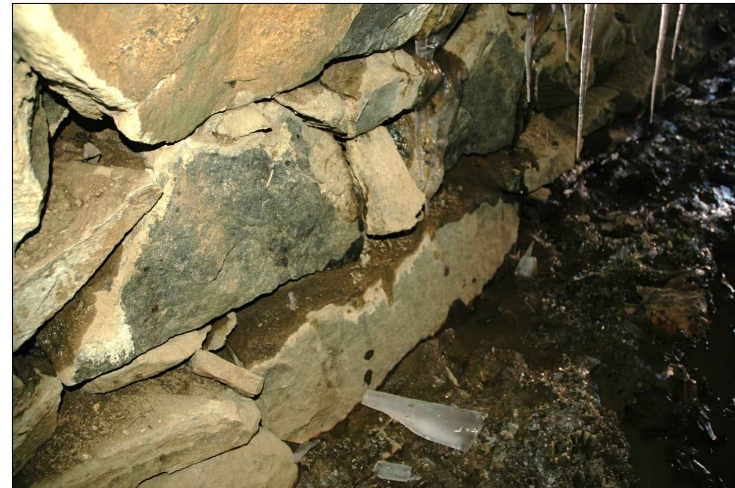
#96 STA 200 NORTH: STONES ARE DRY LAID, VOIDS BETWEEN STONES

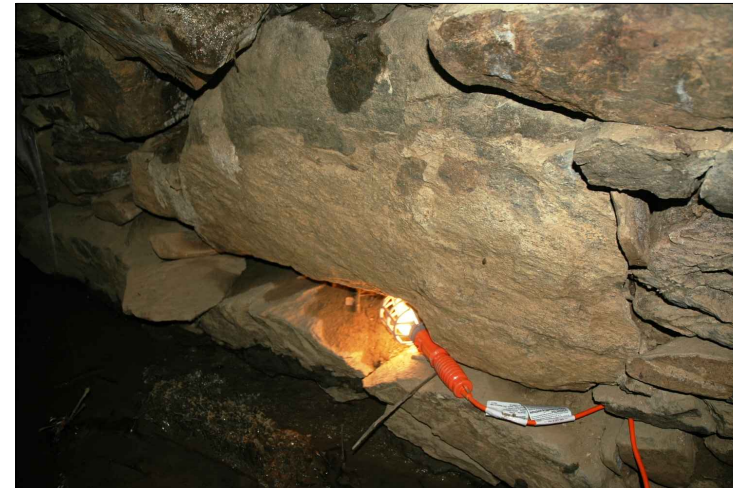
#82 STA 170 SOUTH: LOOSE STONES AND VOIDS

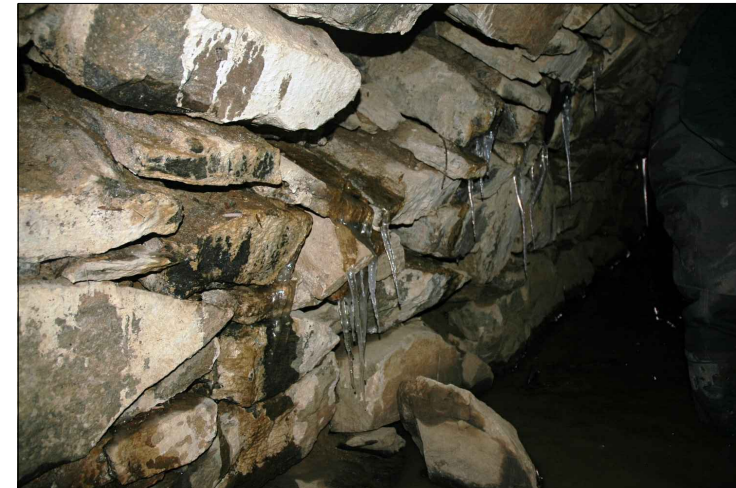
#73 STA 153 NORTH: STONE COLLAPSE, ~24"

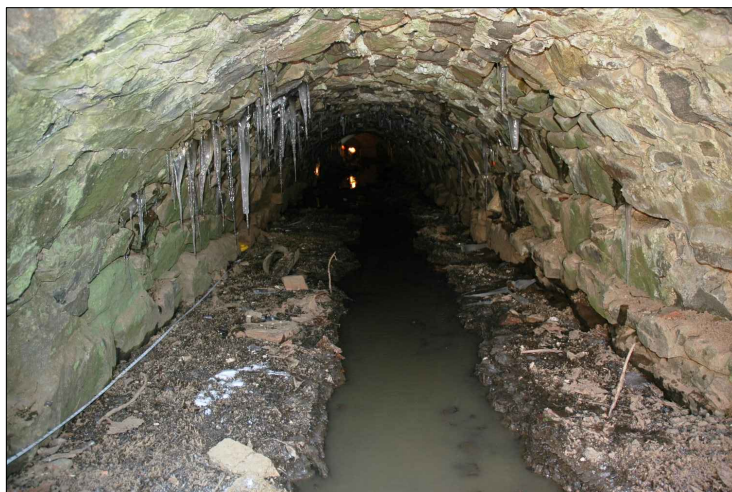
#102 STA 210 (LOOKING WEST): LICHEN ALONG WALLS, ICICLES FROM WATER INFILTRATION, CHANNEL ALONG TAILRACE BASE

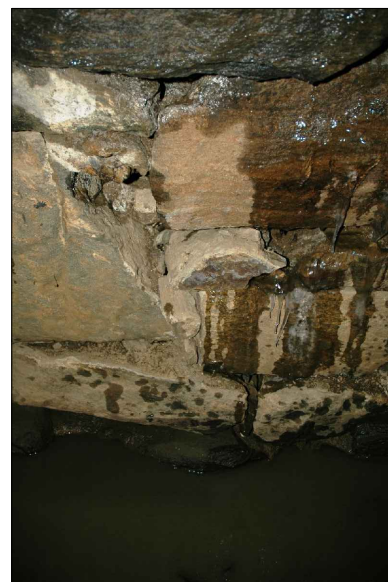
#83 STA 180 SOUTH: STONE LOSS AT BASE, ~14"

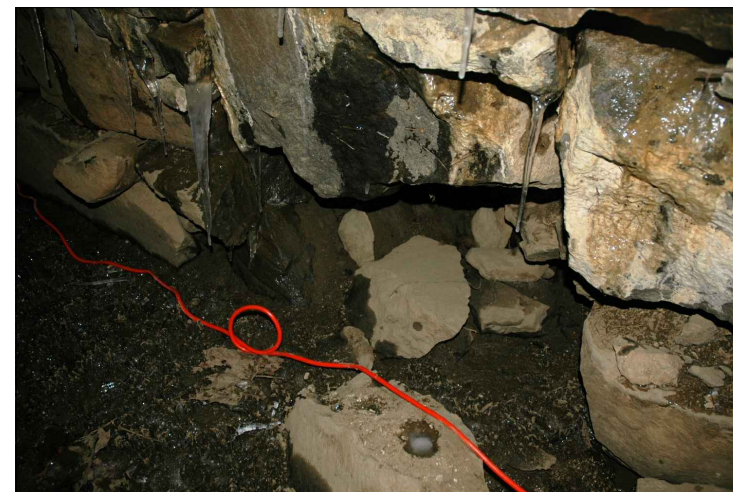
#77 STA 160 SOUTH: STONE COLLAPSE, ~30"

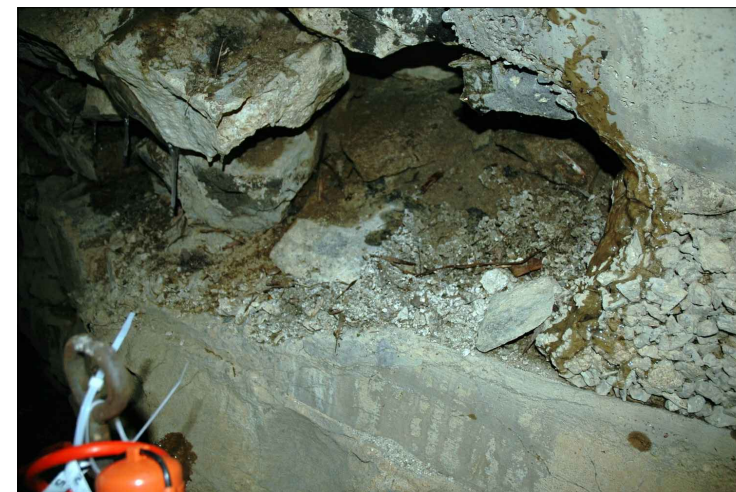
#72 STA 151 SOUTH: STONE COLLAPSE, ~16"
