Restoration Case study Seminar series 1.0

Part One Rooftop plaza restoration

This case Study describes how certain design details combined with environmental factors caused the premature failure of a roof top parking slab in Denver Colorado.

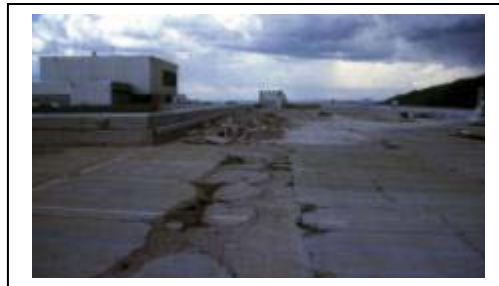
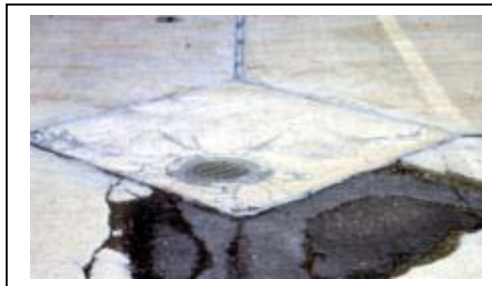
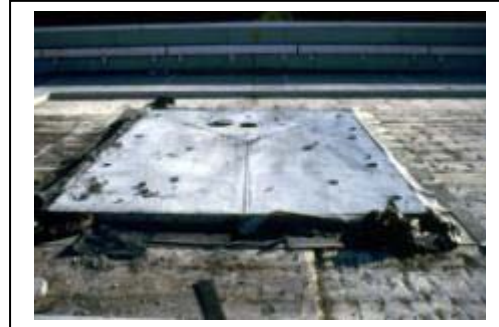
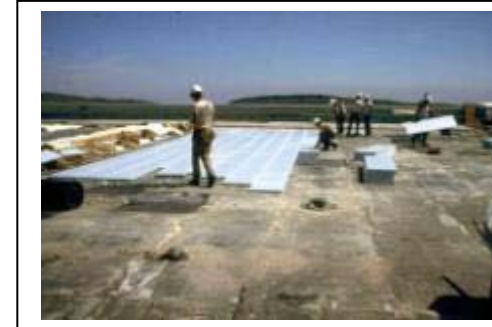
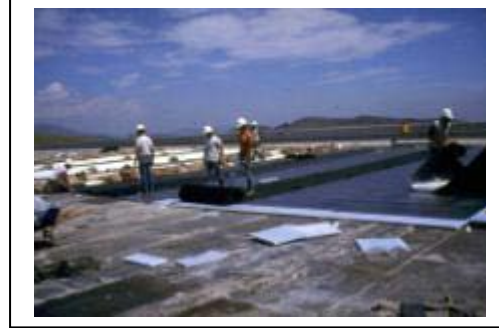
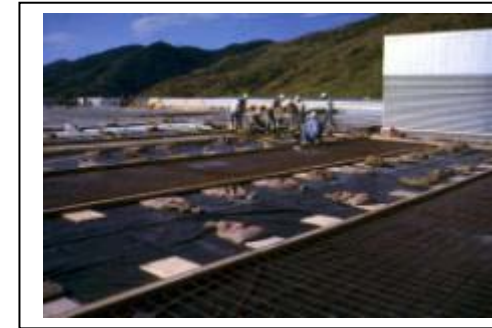
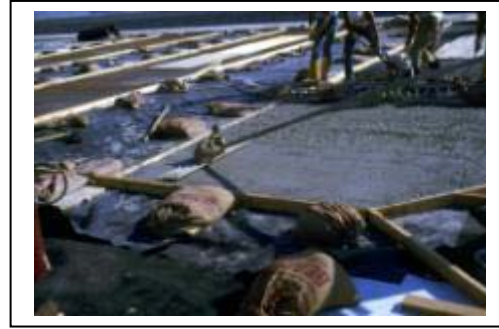
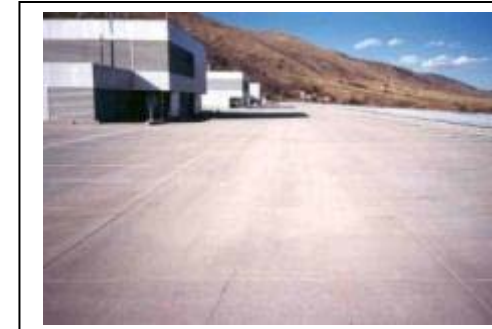
- The failure cause(s) are identified and their effects on integrity and serviceability outlined
- The re-detailing for Proper system DRAINAGE, isolation and movement were developed
- The repair/replacement methods and procedures were engineered
- The constructions plans and specifications were prepared and
- The demolition and replacement construction is presented
- Lastly a 15 year check up was performed photo logged

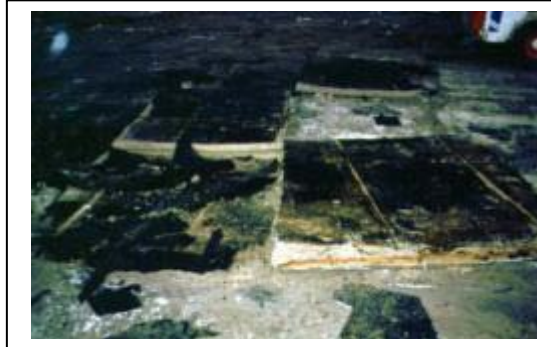
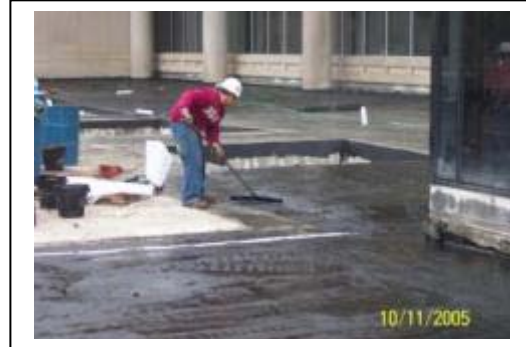
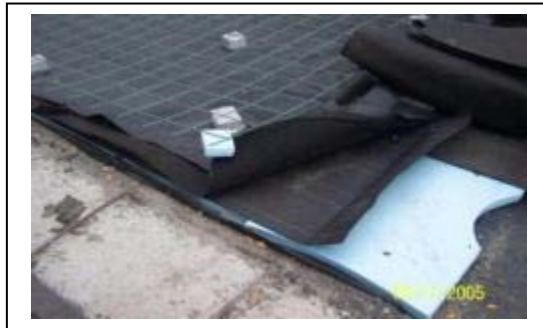
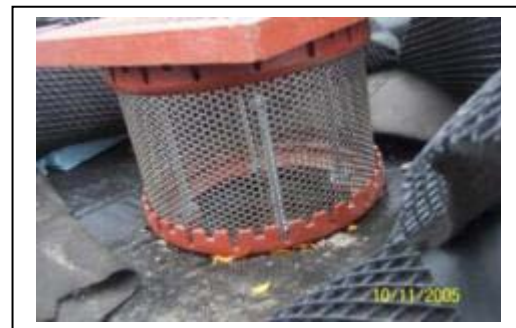
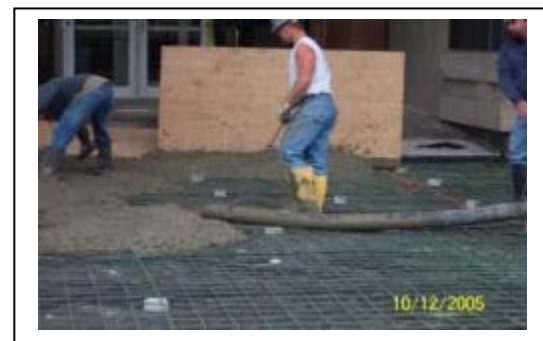
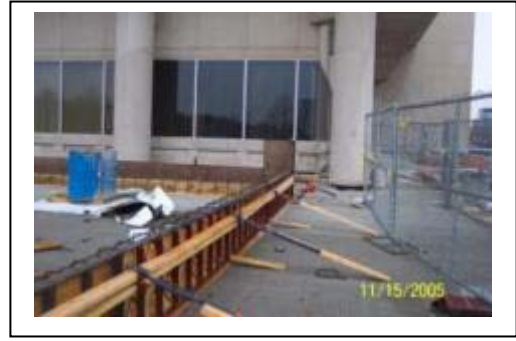
Case study 2- Pedestrian plaza reconstruction - This case study describes the redesign of a plaza (over a parking deck) with certain traffic use and extensive landscaping and special features detailing. It outlines the construction sequencing and details needed to provide a state of the art, 100% replacement of an existing wear surface while keeping the adjacent facilities operating at normal capacity. Concurrent with the plaza restoration the Parking deck slabs below were removed and replaced as well. Project coordination and staging are reviewed. This presentation will relate the same items and issues described (bulleted above) in the first presentation. Project 2006, \$2,400,000

Rebuild of existing failed plaza system @ 20 years with;

- **Membrane-Drainage/Insulation and isolation layer**
- **Isolated Wear slab as Universal base**
- **Drains (Promenade type with subsurface capacity)**
- **Hard-scape features of Brick pavers and concrete**
- **Snow Melt system integrated Concrete and Bricks**
- **Green-scape features including sod areas, Tree wells, common planters**

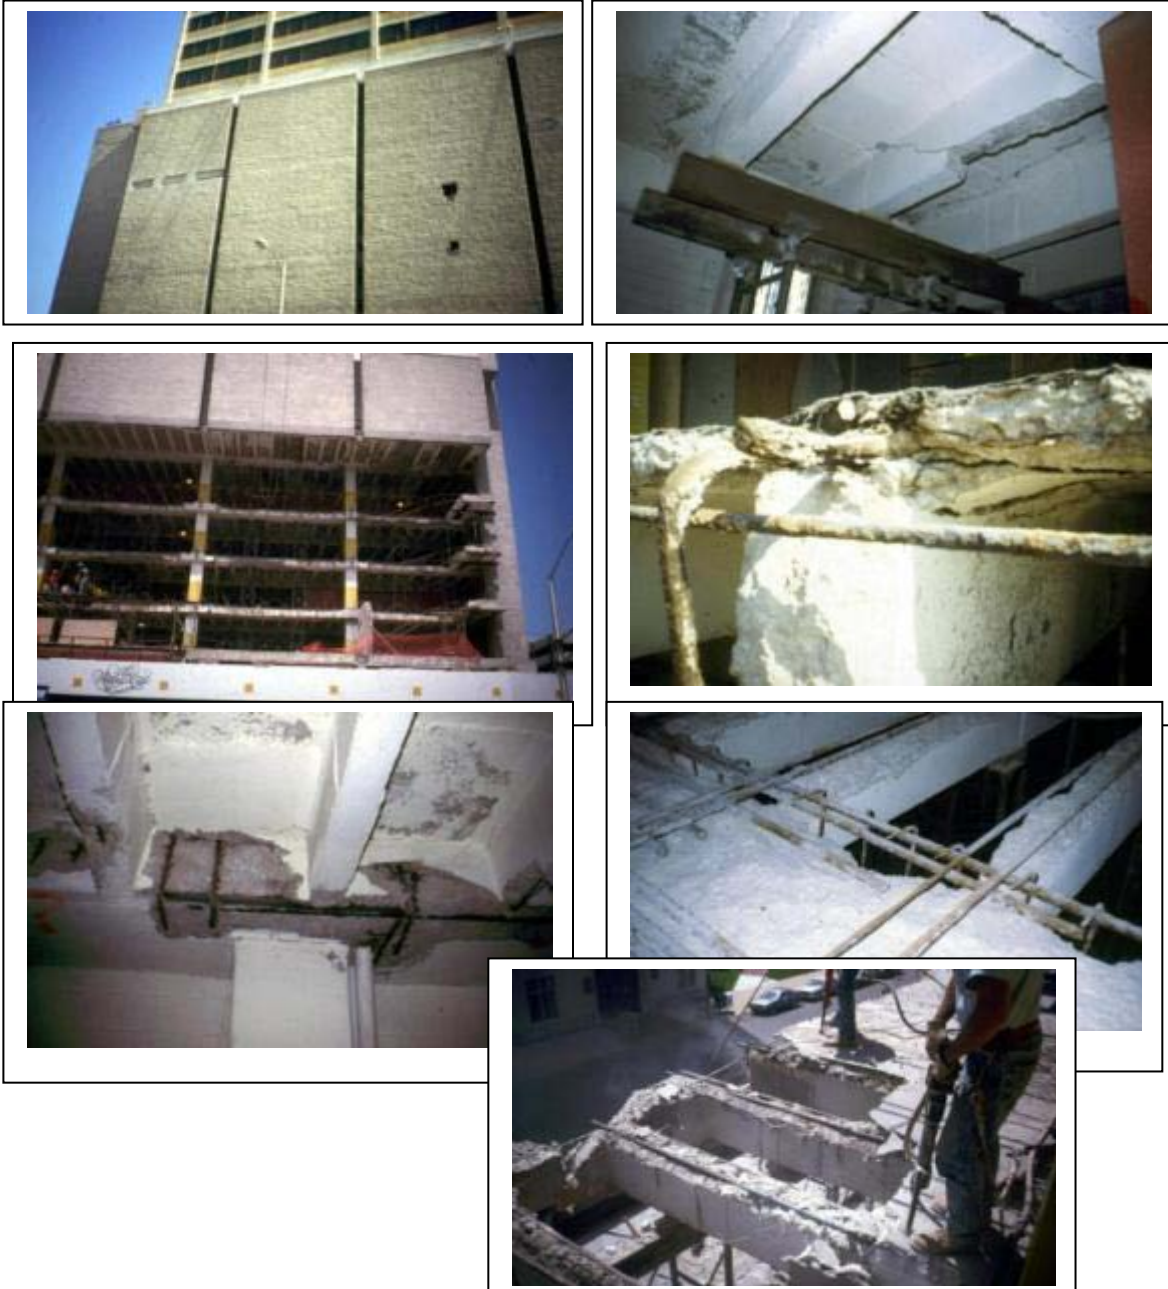
Case study # 3 – Structural Slab and frame replacement beneath a modern 25 story high rise – 1992/92, \$1,100,000

A 30 year old Parking slab system near Chicago was removed and replaced along with the CMU Masonry façade. CIP frame repairs and selective replacements were completed. This case study outlines.

- **Structure evaluation and reporting**
- **Explanation of the Principle deterioration mechanisms**
- **Primary design considerations**
- **Special Shoring/stabilization requirements**
- **Demolition methods and reconstruction sequence**
- **Special durability design procedures (epoxy coated steel and high performance concrete)**
- **15 year performance review and commentary**

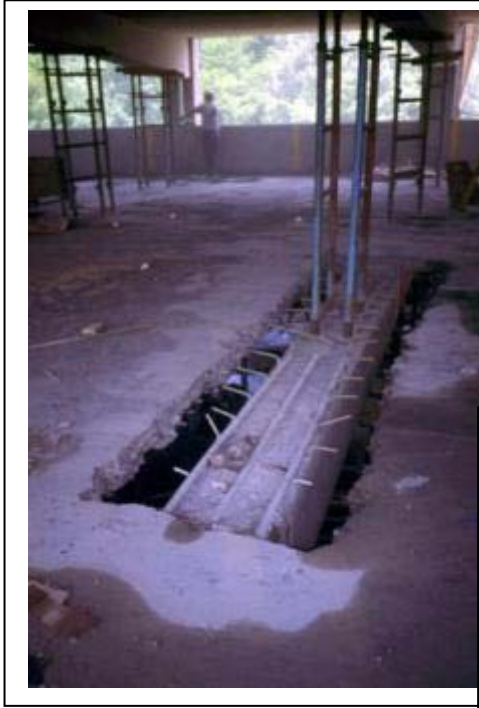
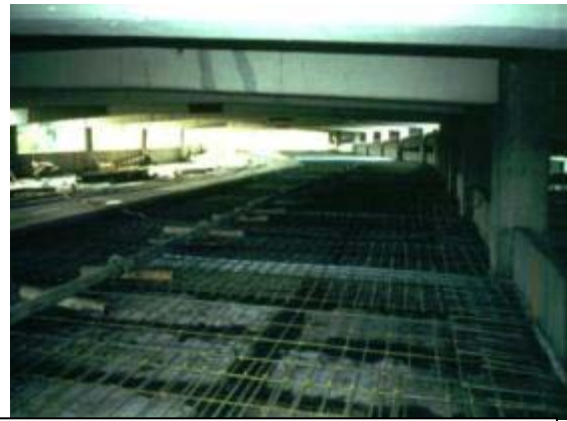
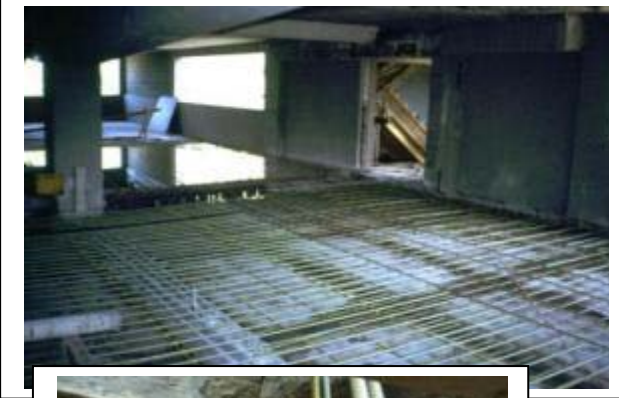
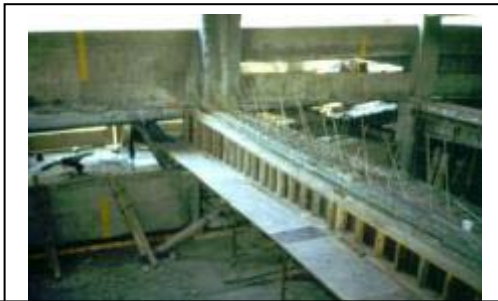
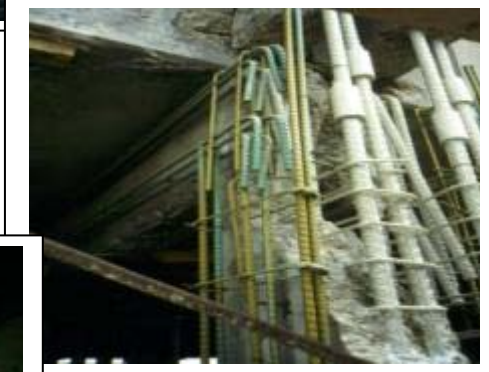
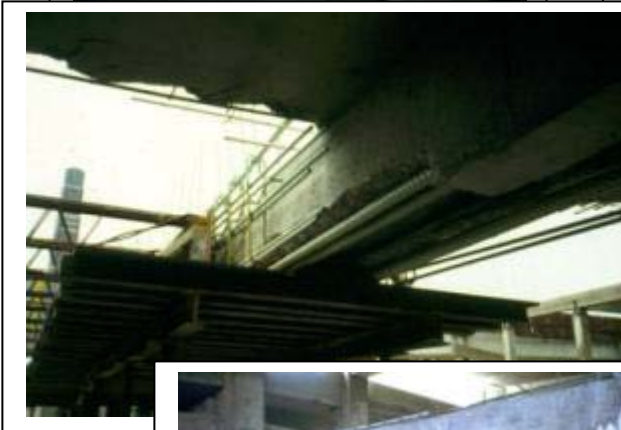
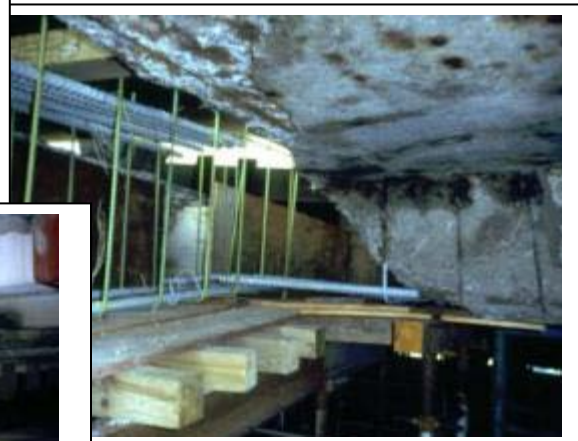
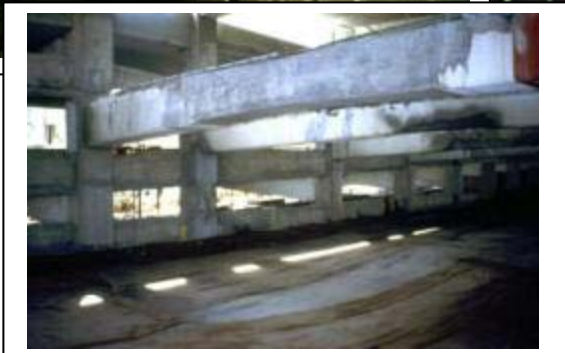
Case Study # 4 Parking Slab Removal Replacement Restoration (1989 at Flint) \$2,700,000

- Existing 30 year old "Parking" slab has corrosion (of embedded reinforcing bars) damage on over 40% of the surface and 25% of the ceiling – Making it essentially unsalvageable

- Isolated "haunched" main beams were showing shear type failure and certain (spandrel) or strut beams were cracked at their junction with the mains.
- Expansion joint beams (and columns) were showing irregular cracking patterns and judged to need stiffening.

- 25 year service life restoration plan was requested by owner with low maintenance expectations.
- Full slab removal and replacement on the lower 3 floors was recommended. Bonded High Performance Overlay was called out for the roof

- Construction was sequenced to;
 - Replace the slab out to (and under) the parapet wall
 - Thicken all expansion joint beams and support columns
 - Repair damaged interior "Main" beams first before slab work

- Do an Outer ring demo and putback first and then continue with an inner ring sequence 2nd
 - Replace the closed in Stairtower masonry with glass curtain walls

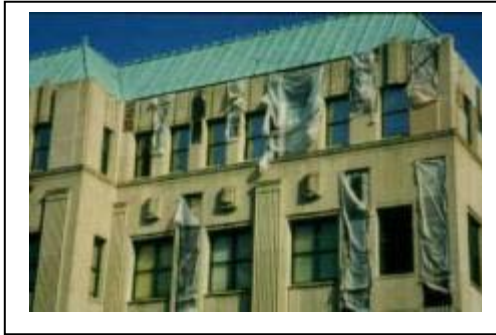
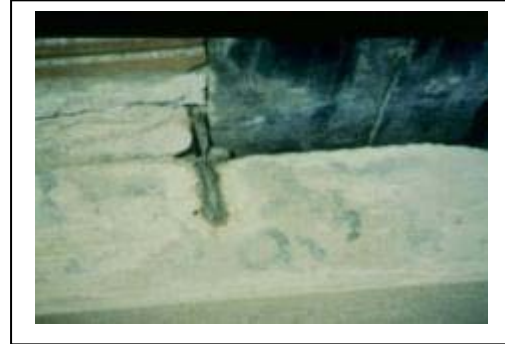
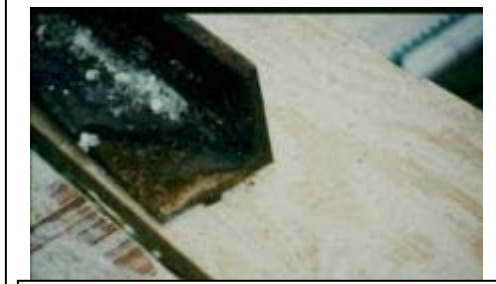
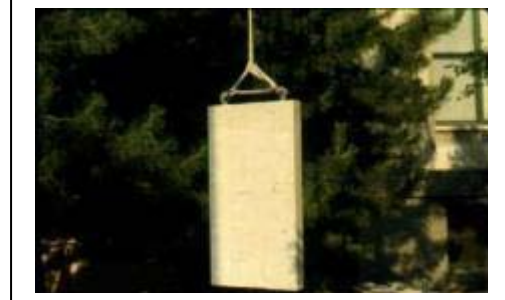
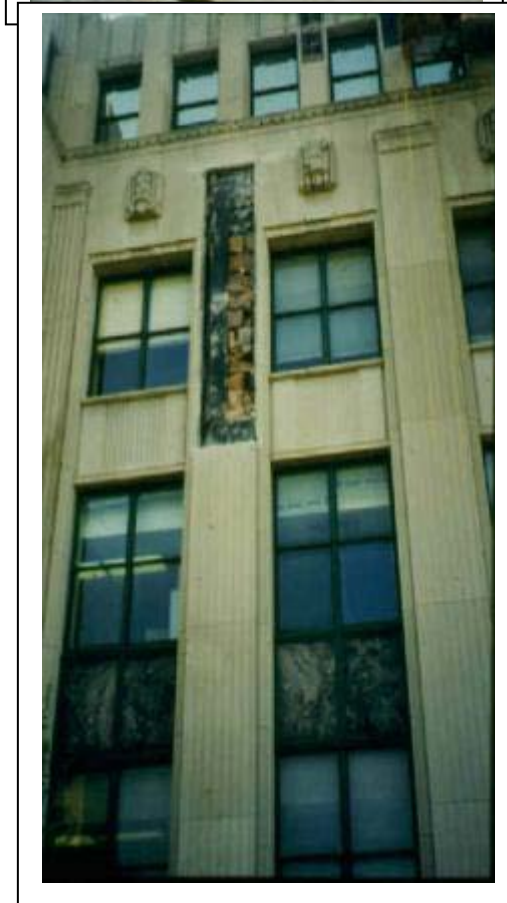
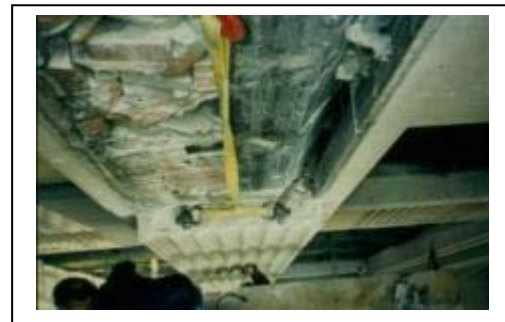
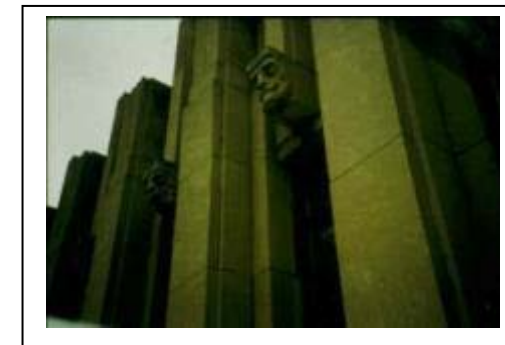
Case study # 5 – Historic Building Exterior Façade Restoration – 1930’s – This structure is clad in ornate limestone panels with major connector and shelf support angle problems. Corrosion damage on many of the angles caused failure of the limestone connectors by spalling of both surface (and backside) limestone sections resulting in indeterminate behavior. Damage panels were dismantled catalogued/inventoried and repaired, primarily by Dutchman methods (partial section removal and replacement). Project Date; 1991---Budget \$750 - \$850,000

- Panel spalling – Face & Backside
- Tieback overstressing/pullout
- Shelf angle corrosion/displacement
- Stone to stone Connector pin failure
- Backup material failure
- Steel frame Corrosion

New anchors were installed in the Virgin panel sections remote from the original failure. Following dismount connector angles/assemblies were removed and replaced with galvanized steel and new connector pins were fabricated for inlaying and concluding repairs to the remaining panels in place.

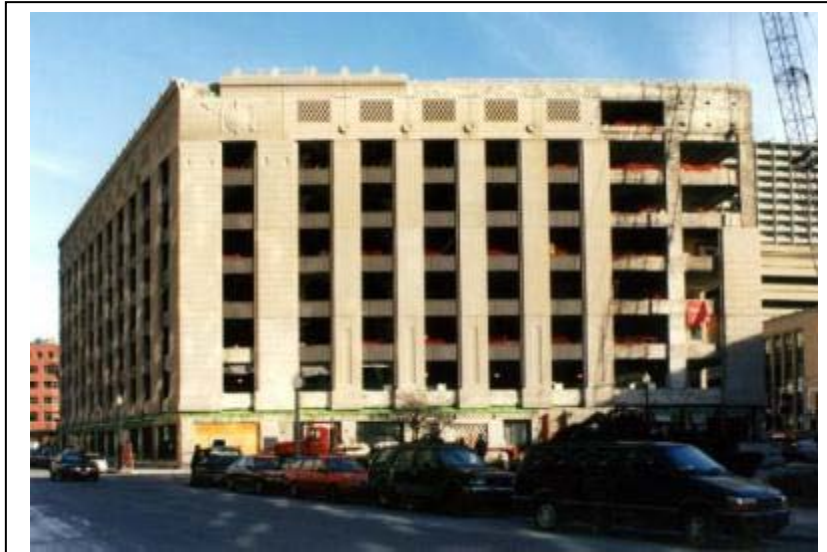
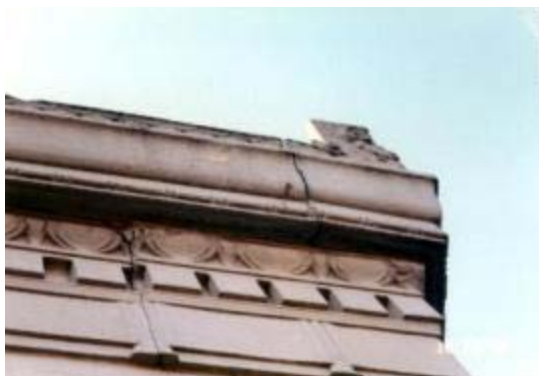
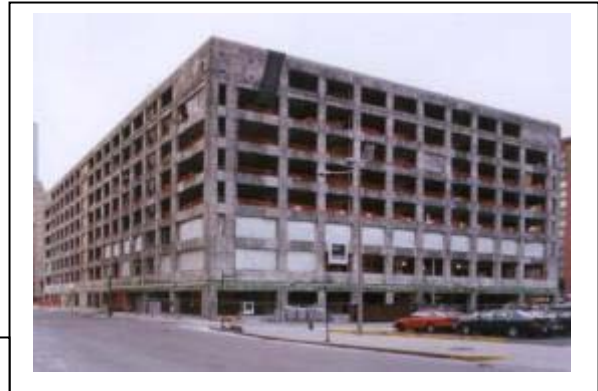
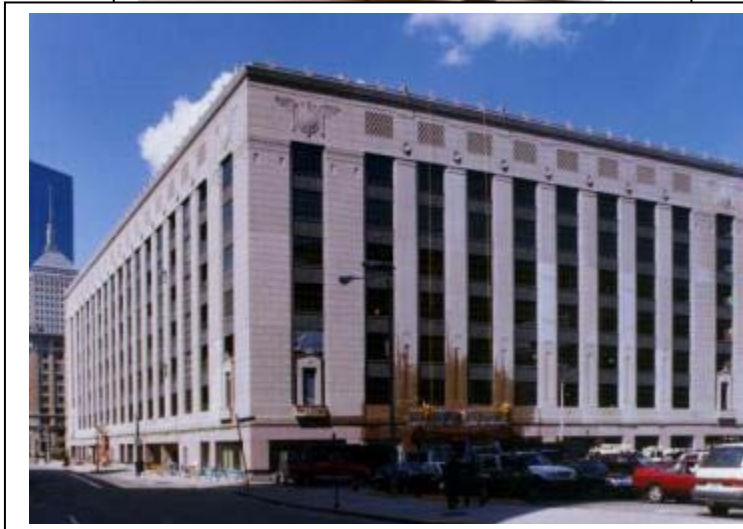
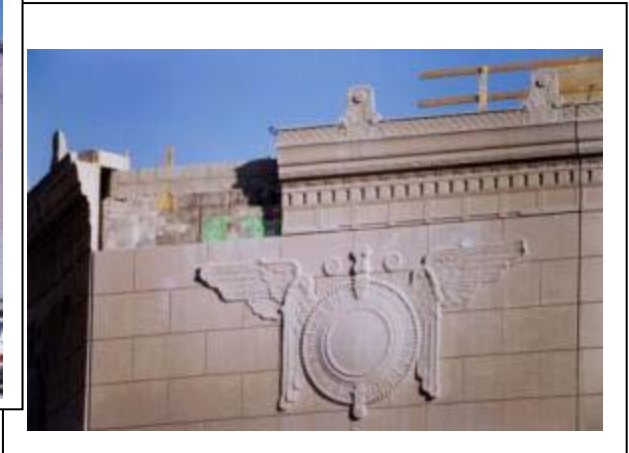
Case Study # 6 – Historic Auto park restoration and up grading - This project qualifies as one-of-a-kind. A reinforced concrete auto park seven stories tall near the core of Boston was completely restored and refitted; Project Date 1997/98, Budget \$21,000,000

- **The parking garage floors beginning at the first level were completely restored and, in certain cases, removed and replaced. (The damage pattern observed was typical with the lower floors showing more severe and extensive corrosion related distress because of the higher amount of chloride deposited. Upper floors were less chloride contaminated therefore the corrosion damage was somewhat less.**

- **The ramps between floors were removed and replaced**
- **New Ramps were added to a roof (8) level (historically covered by a ballasted membrane) and the new parking surface area was installed for an additional 215 cars. The roof level was then coated with a high-performance vehicular deck coating.**

- **The original cast stone facing material and window system along with certain venting features was removed and replaced. The new panels were so designed as to accommodate replacement of nearly 80% of the building façade (a pentagon shaped footprint of 905 feet long by 8 Stories High. Special note Tracy Restoration Engineers performed the original façade survey 1993 indicating certain replacement options.**
- **The damage parapet stones (original limestone in some cases weighing 1500 pounds each) were removed and replaced with GF RC precast concrete elements weighing a fraction of the amount.**
- **The entry and exit lanes were redone to accommodate better traffic flow within the historic structure.**
- **A new garage advertising sign and replicating the original 1930s neon sign was fabricated and hung on Massachusetts Avenue side.**

- **Elevators were installed between the second level and the specialty stores and restaurants**
- **The lobby was reconfigured in rebuilt for improved pedestrian flow**
- **Parking access revenue control systems were updated for improved key card access**
- **Sidewalk entry aprons were redone and pedestrian security features also emplaced.**

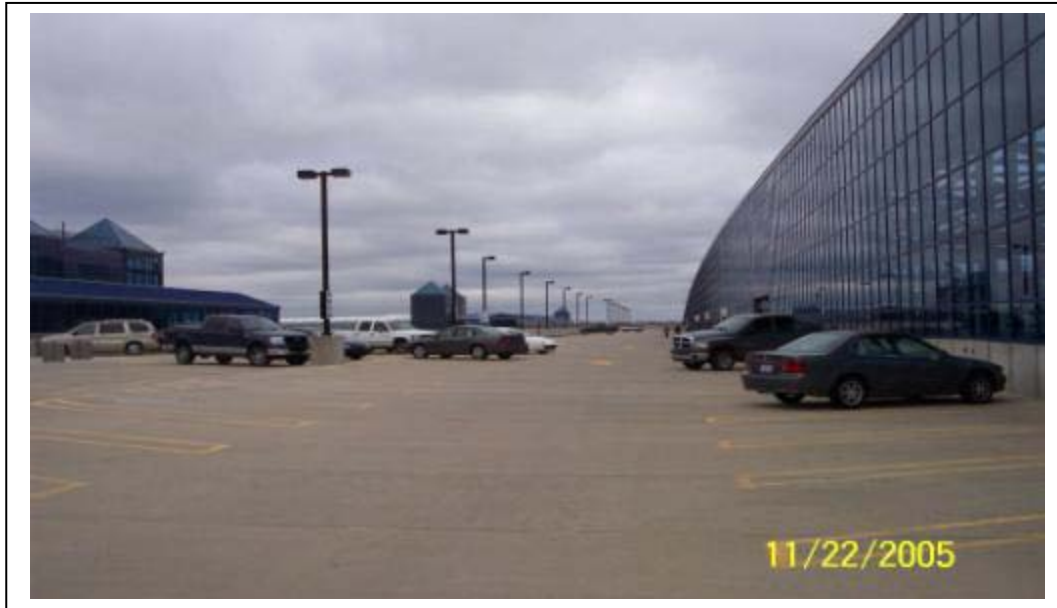
- 1) **Drain basin restoration** -Drain basins on the rooftop, originally constructed to accommodate the pre-casters production system had leaked sense the earliest days of facility operation. Leaking caused rapid/ progressive corrosion of the connectors, pipes, fittings and constant staining the vehicles below. Double drains installed as part of original construction were replaced with larger single drains encased in substantial concrete block-outs to avoid leaking and movement. The new drain eliminates piping and provides for easier maintenance with the appropriate clean outs.

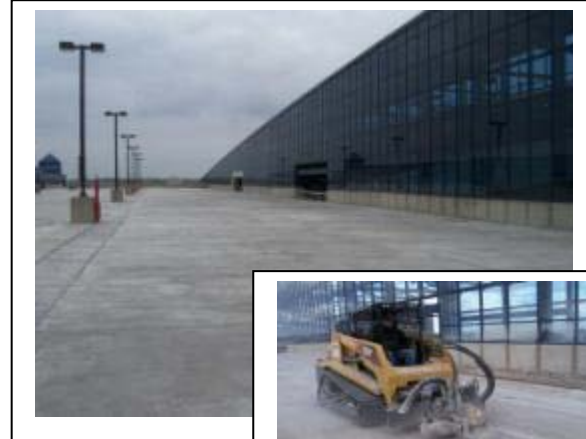
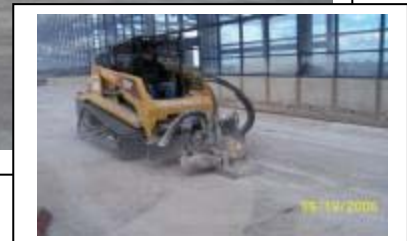
- 6) **Overlay placement - drainage grade improvements** The existing deck surface consisted of lightweight aggregate double Tees of the Pretopped variety. Although designed the grade lines provided satisfactory macro drainage, many of the T's were installed with variations in the upper flange surface. This produced micro ponds on many of the T's in the drain line region and caused considerable difficulty during snowplowing when the equipment damaged elevated tee edges.

- 7) **To correct these numerous conditions**, the existing deck surface was milled down 1 in. for a new 1-1/2in. thick overlay of latex modified concrete. The new surface provides improved long-term durability over the lightweight Aggregate concrete, improves drainage gradients to reduce micro ponding, accommodated providing smaller joints, and eliminates differentials, improving the overall ride and reducing future distress from snowplowing operations.

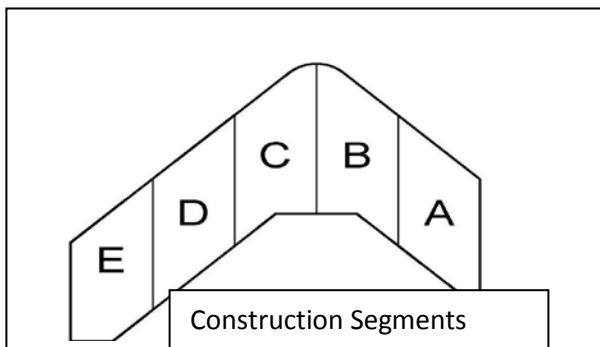
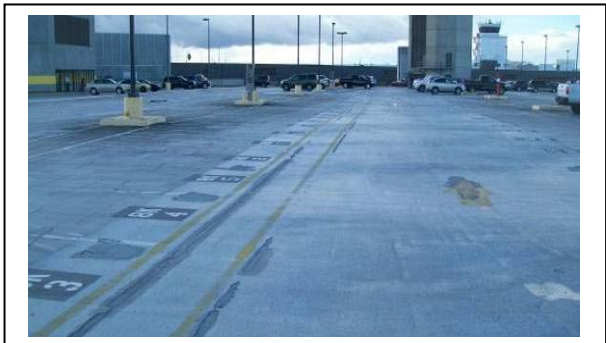
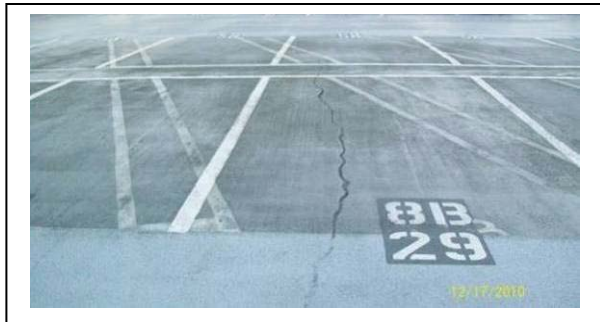
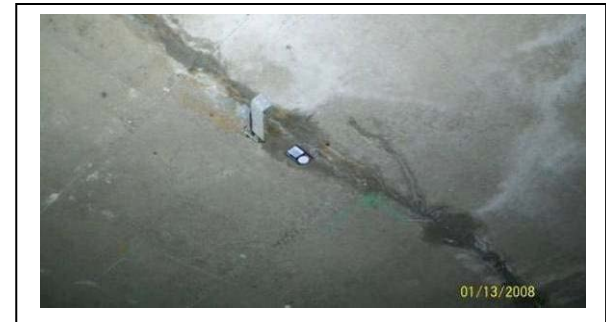
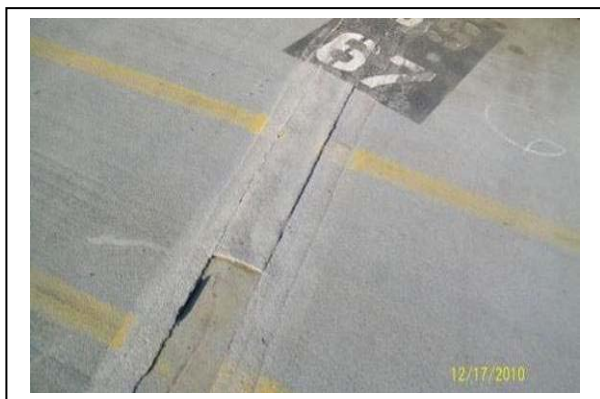
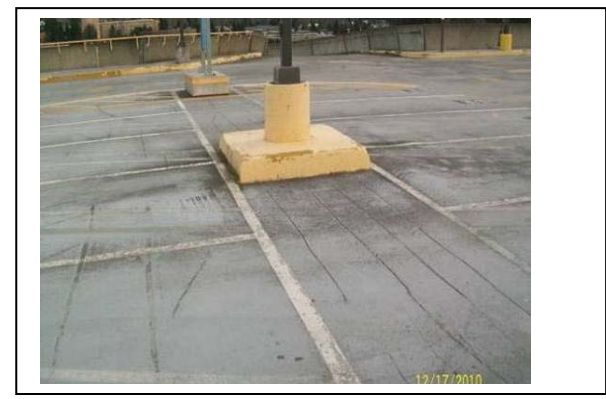
Investigation and condition assessment of a 4 generation (phased original construction) parking deck and development of a rooftop restoration program with 600,000 SF per floor. 2010/11 \$6.75 million. Identified the principle deterioration mechanisms, affecting structure integrity and serviceability, within the following work groups;

- Floor surface conditions (all 4 design types and ages)
- Joint Condition (seismic design features) for upgrade and durability enhancements
- Ceiling surface conditions
- Drainage and drivelane overlay considerations
- Stairtower upgrades and improvements
- Exit apron reconfigurations for refit joints
