Western Clay Manufacturing Company Conservation Praxis 2012 Field Report

Archie Bray Foundation
Montana Preservation Alliance

The Architectural Conservation Laboratory
School of Design
University of Pennsylvania
December 2012

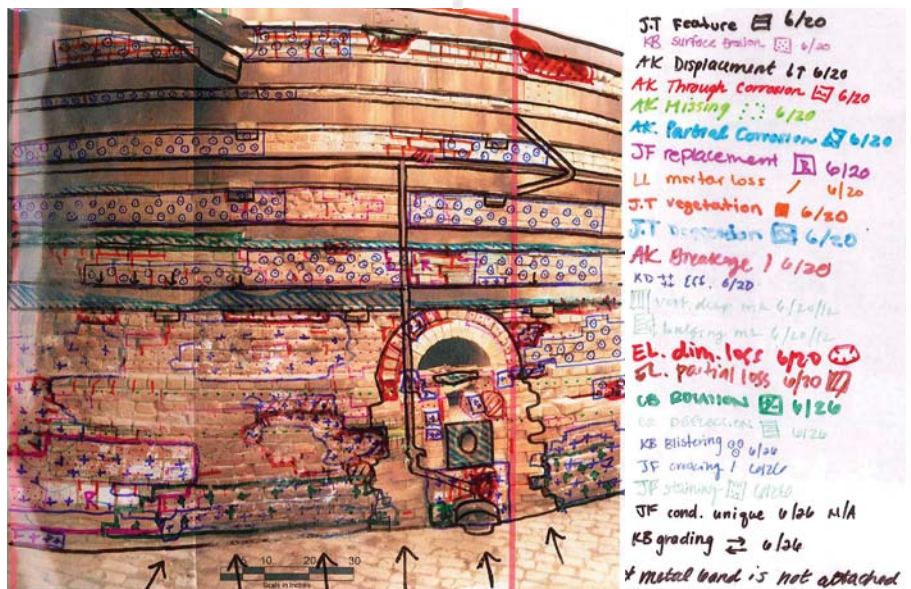
One section of Kiln No.7 in which conditions recorded in the field were overlaid on top of an image. The scan was then later digitized.

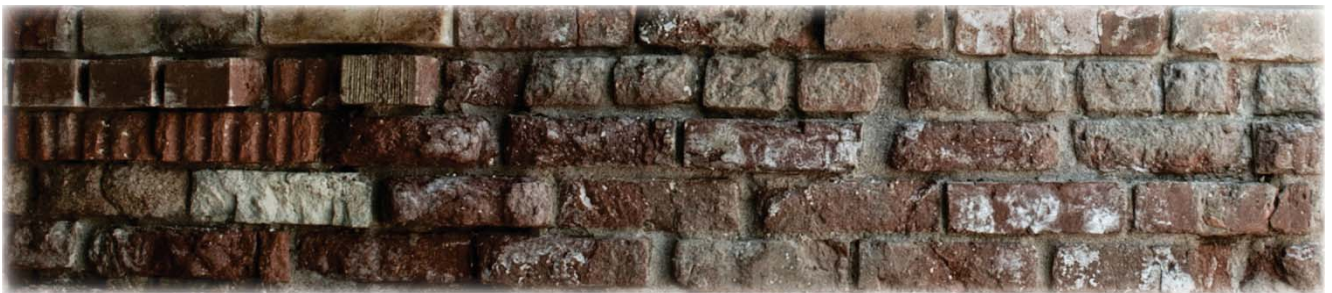
A detailed photo of Kiln No. 7 West elevation illustrating the various conditions and types of bricks associated with different phases in construction, repair, and ongoing restoration.

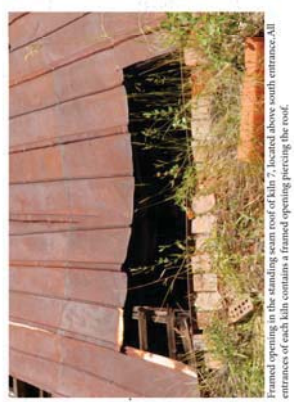
Framed openings at the east and west ends of Kiln 7. Inward above south entrance. All entrances of each kiln contains a framed opening protecting the roof.

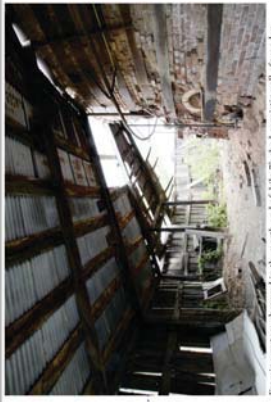
Framing system observed in the north end of kiln #7, abut consisting all of wooden members. The north framed opening in view (in background to the right).

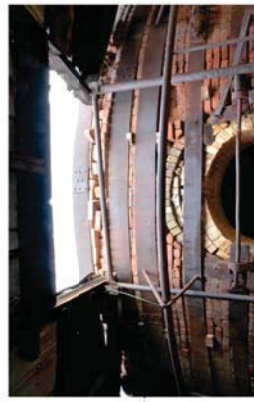
Framing system in the main span roof of kiln #7. After firing, the kiln doorways are opened releasing heat and water vapor. The framed opening allows the heat and water vapor to escape through the kiln shed.

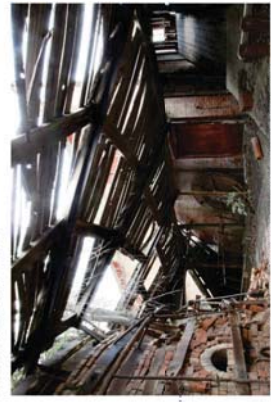
Framing system observed in the northwest end of kiln #4 shed. Wooden rafters are pulled to wooden runners. The wooden rafters sit on splayed iron angles that are anchored into metal post.
