THE NEWLIN GRIST MILL TAILRACE EXISTING CONDITIONS ASSESSMENT

209 SOUTH CHEYNEY ROAD
GLEN MILLS, PA 19342

J&M PRESERVATION
STUDIO

COVER SHEET

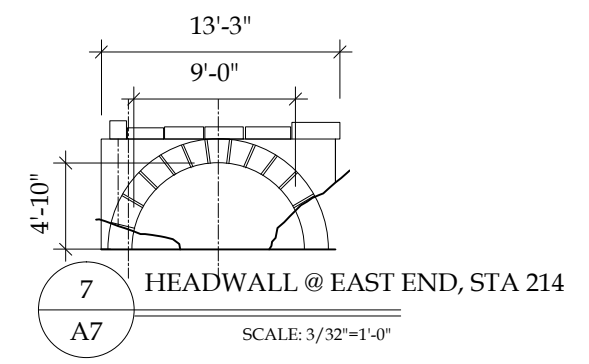
3 STA 151-214: NORTH ELEVATION WALL - CONDITIONS
SCALE: 3/32"=1'-0"

STA 180: TWO VOIDS OVERHEAD. MAJOR EFFLORESCENCE. VERY LARGE STONES, 36"-38" LENGTH.

STA 170: MAJOR EFFLORESCENCE. VERY LARGE STONES, 36"-38" LENGTH.

STA 153: MAJOR STONE COLLAPSE, 24" WIDE STONE FELL.

STA 190: SMALLER STONES AT BASE, LARGE BOULDERS AT MIDPOINT, LOOSELY LAID. ICICLES OVERHEAD.

STA 200: SMALLER STONES AT BASE, NOTCHED STONE INDICATES THAT THIS PARTICULAR STONE WAS SALVAGED FROM ANOTHER SOURCE/BUILDING.

STA 200-214 LICHEN ON WALLS. SMALLER STONES AT BASE, LOOSELY LAID, MORE STABLE THAN STA 160-180.

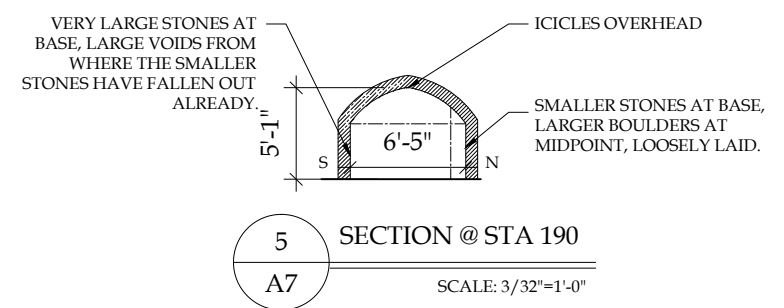
1 STA 151-214: SOUTH ELEVATION WALL - CONDITIONS
SCALE: 3/32"=1'-0"

STA 180: STONE LOSS AT BASE OF FOUNDATION ~14". STONES ARE LARGE IN THE AREA, LOOSE & DRY PACKED.

STA 190: VERY LARGE STONES AT BASE. LARGE VOIDS FROM WHERE THE SMALLER STONES HAVE FALLEN OUT ALREADY.

STA 200-214: LICHEN ON WALLS.

STA 190-214: VERY LARGE BOULDERS AT BASE OF WALL.

STA 151: STONE COLLAPSE ~16".

STA 160-162: STONE COLLAPSE ~30".

STA 170: STONES COMING OUT, LOOSE & HANGING.
