“... A Monument to Misguided Enterprise”: The Carp River Bloomery Iron Forge

David Landon, Patrick Martin, Andrew Sewell, Paul White,
Timothy Tumberg, and Jason Menard

The mid-19th-century Carp River Forge was the first iron smelting operation on the Marquette Iron Range, launching the iron industry of Michigan's Upper Peninsula. At the forge, skilled ironworkers produced iron in bloomery hearths using charcoal, ore, and a water-powered air blast. This paper presents the results of the historical research and three seasons of excavation at the site. Major archaeological discoveries include the dam base, the water wheel gudgeon and crank, parts of the bloomery forges, a blacksmith's forge base, and the remains of houses for the forge workers. The archaeological remains of the bloomery forges suggest the forge workers employed the latest hot-air blast and firebox design. The spatial distribution of the ore, charcoal, and waste slag, in conjunction with the industrial features, defines the layout and organization of the industrial workings. The Carp River Forge is one of four short-lived bloomeries from the early days of the Marquette Iron Range, and it typifies the difficulties fac

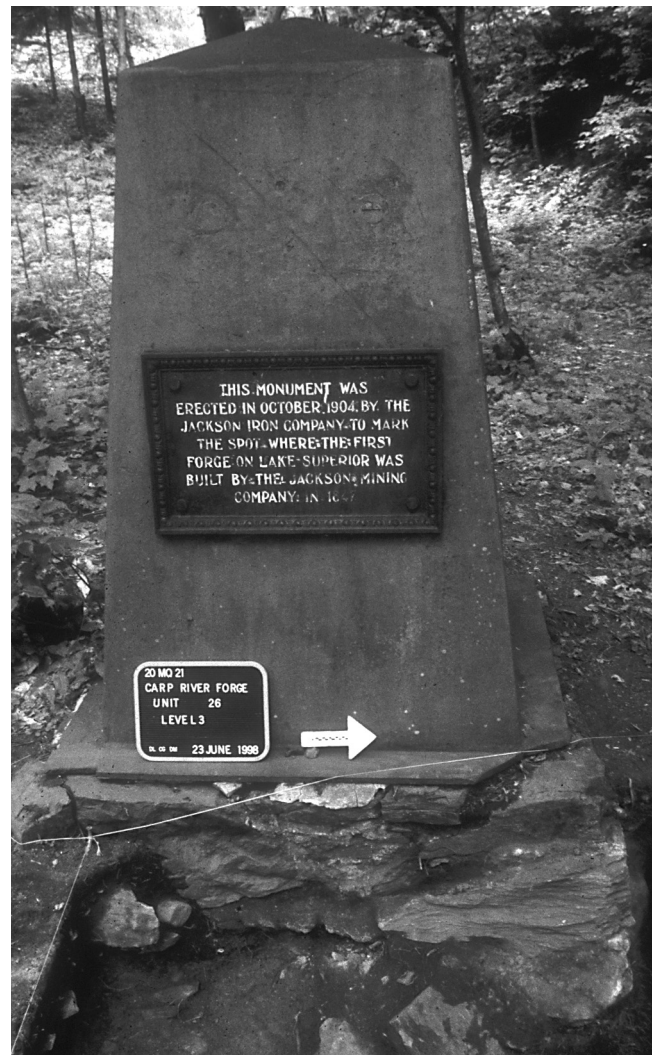
Figure 2. Monument erected at the site of the Carp River Forge. This piece is made of cast-iron plates put together in the shape of an obelisk. Photo by Landon.

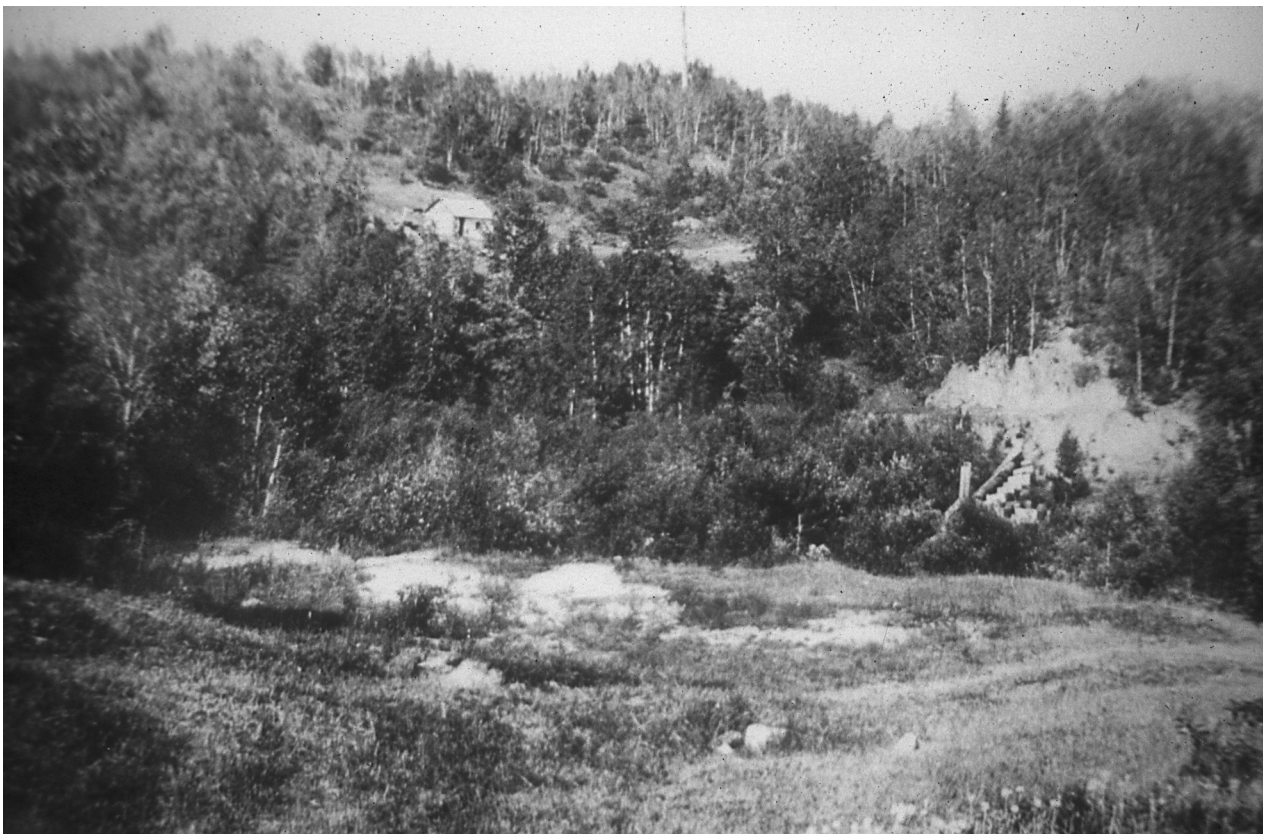
Figure 7. *The Carp River Forge, looking east (c. 1900), one of the few historic photos showing the site. The wooden timbers visible among the trees in the center of the picture are the upper parts of the dam. Note the tree growth upstream of the dam to the left. The ore kiln is just outside the edge of the picture to the right. The bright area behind the dam is an exposed face of schist, somewhat more overgrown but still visible today.*

rather poor quality shot of the dam, showing that the main superstructure of this dam was made from unhewn logs, faced with planking on the upstream side (Figure 7). Today the dam is breached at the western end, the superstructure is entirely gone, and only the buried portions of the eastern cribbing and massive amounts of fill survive.

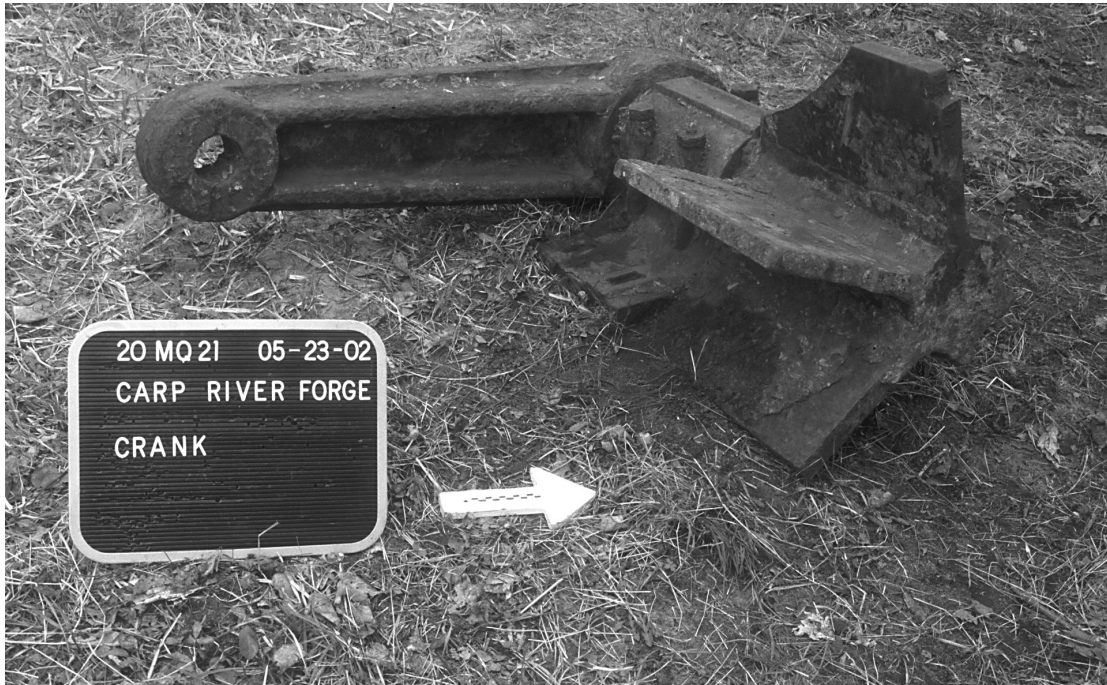
Figure 8. Water wheel gudgeon from the Carp River. The cast-iron flanges on the right would have fit into the end of the water wheel axis timber. The bearing in the center of the gudgeon is held together by four large bolts.

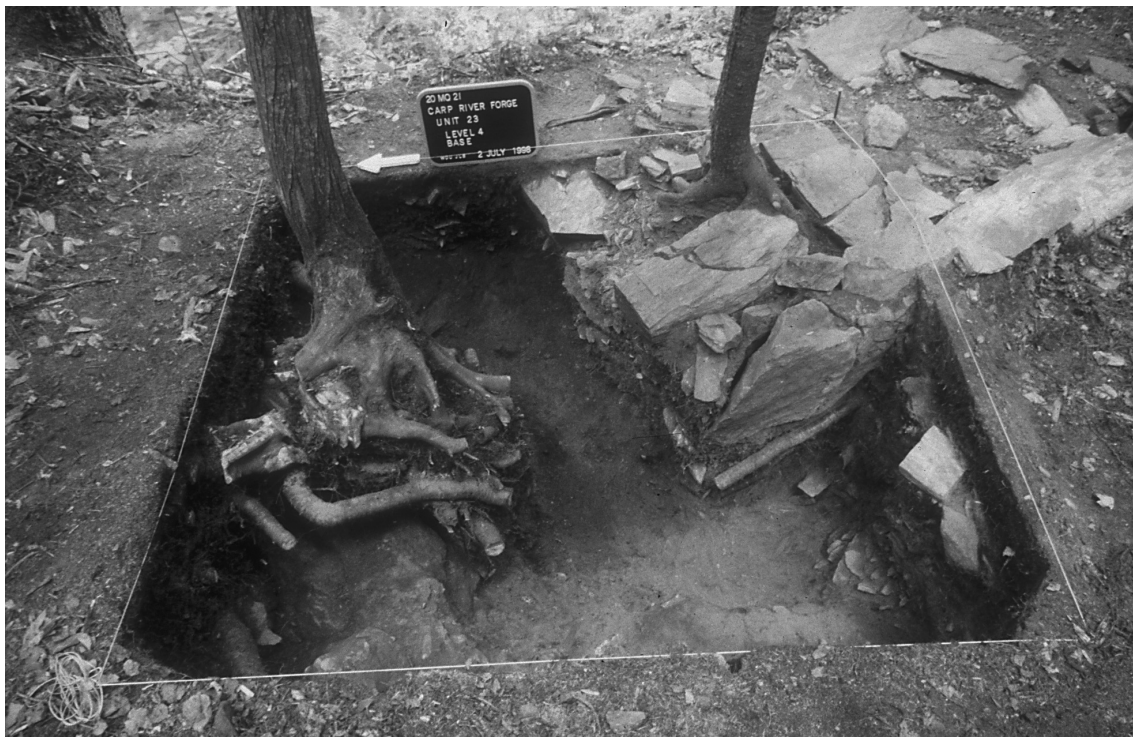
Figure 9. Forge base, looking east. The Carp River is just visible in the upper right-hand corner of the photo. This excavation unit encountered thick deposits of charcoal, sand, and slag, which included blacksmithing artifacts like wrought nails, oxen shoes, and iron scrap.

During the Jackson Company's initial occupation of the site, two cold-blast forges made the iron. Details of these forges remain sketchy. We have found only one intact forge base on the site, a square structure made of rough-cut, dry laid, locally quarried schist (Figure 9). Most of the slag recovered from around this forge has a very low iron

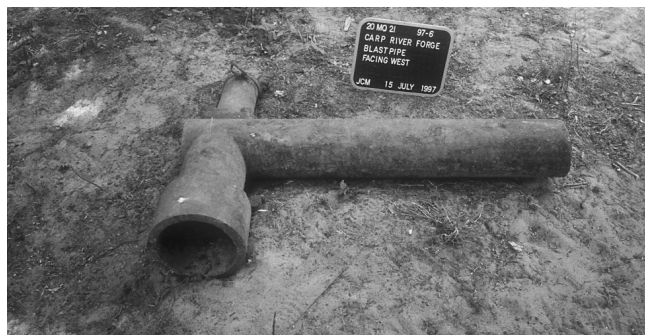
Figure 10. T-shaped air blast pipe pulled from the bottom of the Carp River. The Eatons used cast-iron pipes like this in the stack of the forges, heating the air for the blast. Photo by Martin.

The physical evidence for the hot-air blast forge configuration at Carp River includes sections of cast-iron air blast pipes and eight cast-iron firebox plates. The air pipes include a flanged pipe and a T-shaped pipe with a now inoperable mechanism to open and close the pipe, presumably controlling airflow into the forge (Figure 10). The firebox components include two cinder plates, two tuyere plates, two merritt plates, and two broken, unidentified plates (Figure 11). These metal plates would have formed the lining of the forge firebox and been surrounded by a masonry structure. None of the plates were in their original location, though they were found clustered in the area just downstream from the forge base discussed above. All told, parts of the firebox and air pipes for two of the four hot blast forges were recovered.
