SOCIETY FOR INDUSTRIAL ARCHEOLOGY

NEWSLETTER

HAER SETS MS LIBERTY'S RECORD STRAIGHT

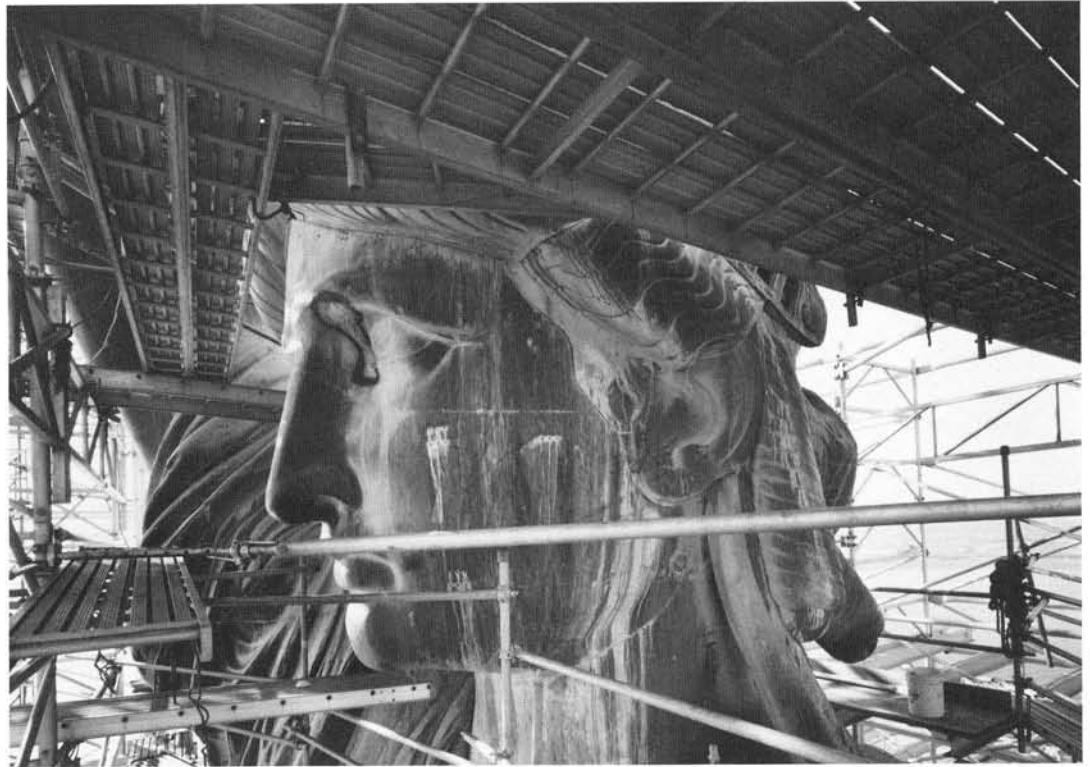
Liberty's magnificent head. The dark area at the eye marks a graft of new copper skin. The lobe of the nose also has been repaired. Streaks on the face and neck were caused by a bicarbonate-of-soda solution, used to remove coatings on the interior surface, which oozed through joints between copper plates and through the holes for rivets connecting the skin with iron support straps on the inside. *Jet Lowe photograph for HAER (12-85).*
